Review of common construction practice finds environmental contamination, need for improved oversight and monitoring

May 15 2018

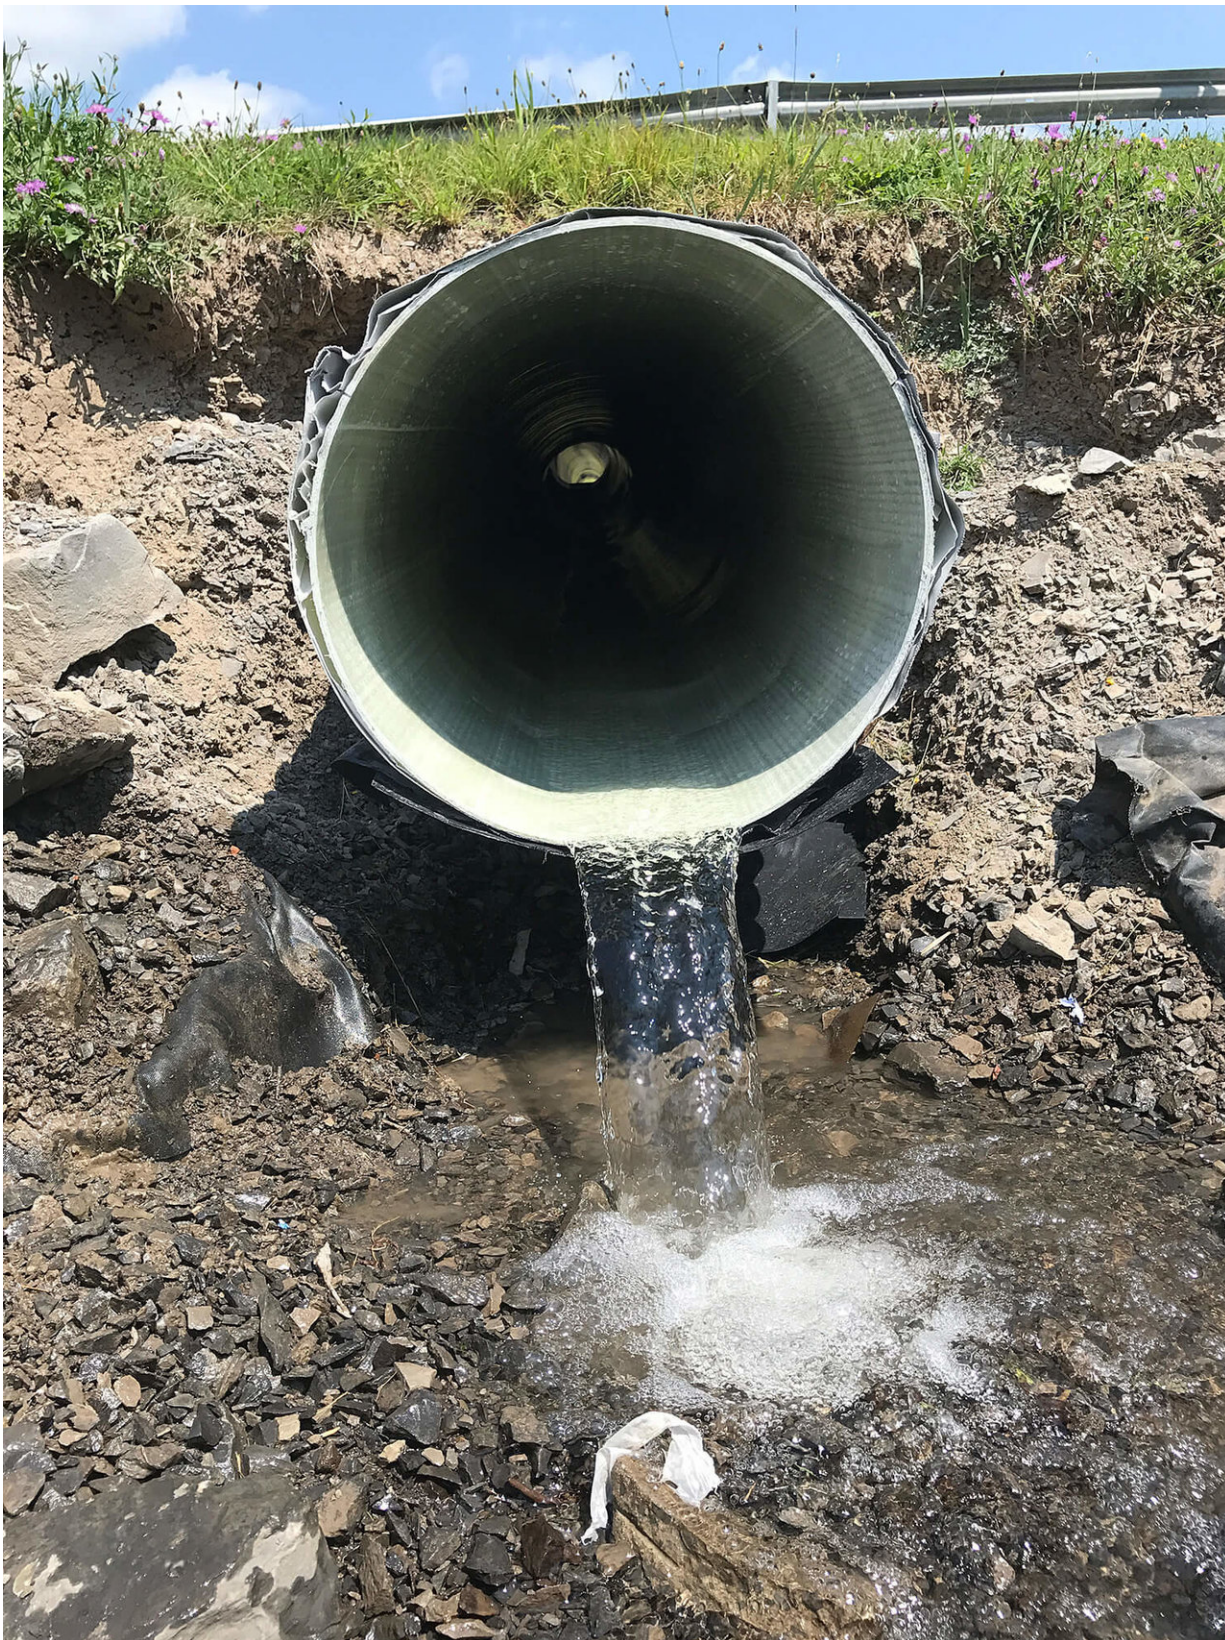
A common water pipe repair process that uses resin to build a new liner in existing pipe is coming under increased scrutiny because of concerns about environmental and health effects, say researchers at Purdue University. Credit: Purdue University

A popular method of repairing culverts, CIPP utilizes resin-impregnated fabric that is hardened inside a damaged pipe using pressurized steam, hot water, or UV light, creating a new plastic pipe inside the old, damaged pipe.

The process, if not well controlled, can release a worrisome mix of hazardous chemicals into the air and water, although what exactly is discharged, and how that varies site to site, is just beginning to be understood.
