# Bridge in Italy had unusual design, required constant work (Update)

August 16 2018, by Alexandra Olson

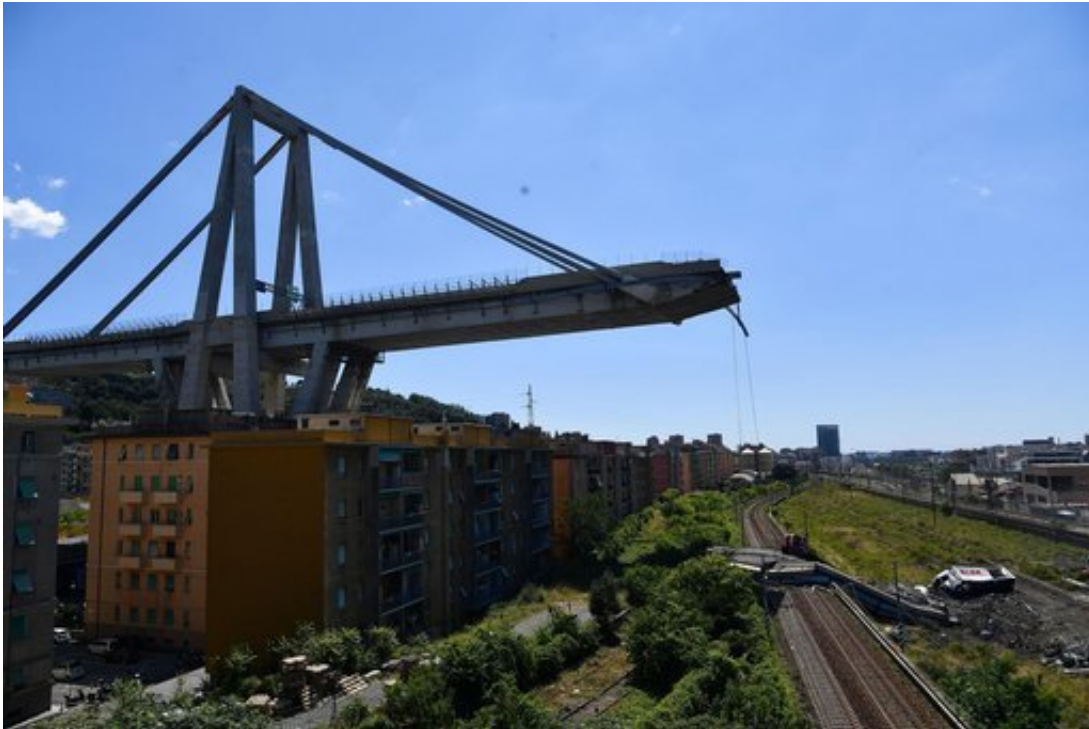
A view of the evacuated houses built under the remains part of the collapsed Morandi highway bridge, in Genoa, northern Italy, Wednesday, Aug. 15, 2018. A bridge on a main highway linking Italy with France collapsed in the Italian port city of Genoa during a sudden, violent storm, sending vehicles plunging 90 meters (nearly 300 feet) into a heap of rubble below. (AP Photo/Nicola Marfisi)
