## Opportunity rover emerges in a dusty picture

September 25 2018

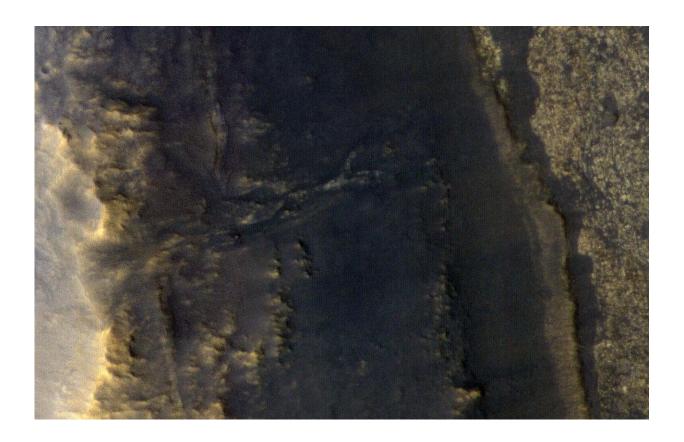
NASA's Opportunity rover appears as a blip in the center of this square. This image taken by HiRISE, a high-resolution camera onboard NASA's Mars Reconnaissance Orbiter, shows the dust storm over Perseverance Valley has substantially cleared. Credit: NASA/JPL-Caltech/Univ. of Arizona

A new image produced by HiRISE, a high-resolution camera aboard NASA's Mars Reconnaissance Orbiter (MRO), shows a small object on the slopes of the Red Planet's Perseverance Valley. That object is Opportunity, which was descending into the Martian valley when a dust storm swept over the region a little more than 100 days ago.

The tau—a measurement of how much sunlight reaches the surface—over Opportunity was estimated to be a little higher than 10 during some points during the dust storm. The tau has steadily fallen in the last several months. On Thursday, Sept. 20, when this image was taken, tau was estimated to be about 1.3 by MRO's Mars Color Imager camera.

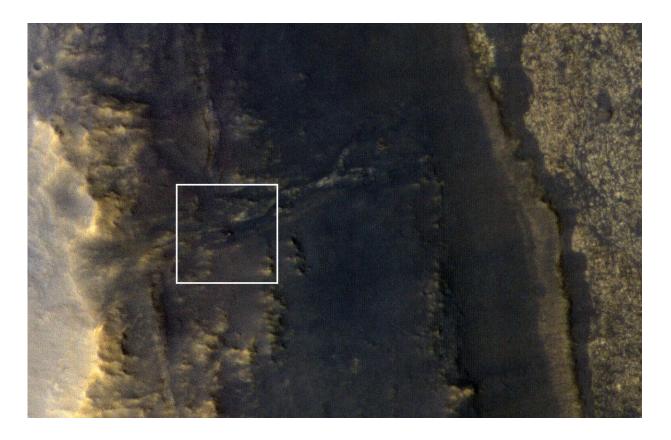
This image was produced from about 166 miles (267 kilometers) above the Martian <u>surface</u>. The white box marks a 154-foot-wide (47-meterwide) area centered on the rover.
