Hubble moving closer to normal science operations

October 23 2018

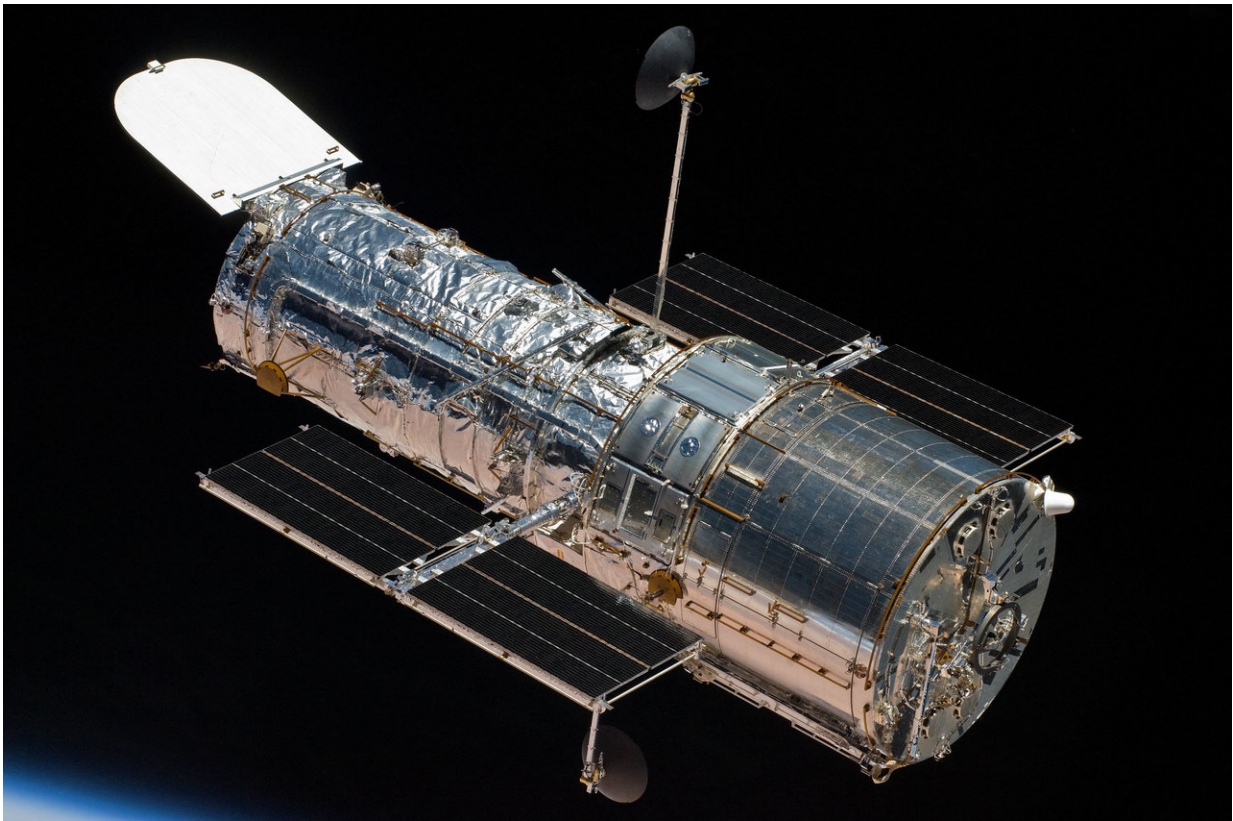
NASA's Hubble Space Telescope. Credit: NASA
