## The 'camera that saved Hubble' turns 25

December 5 2018

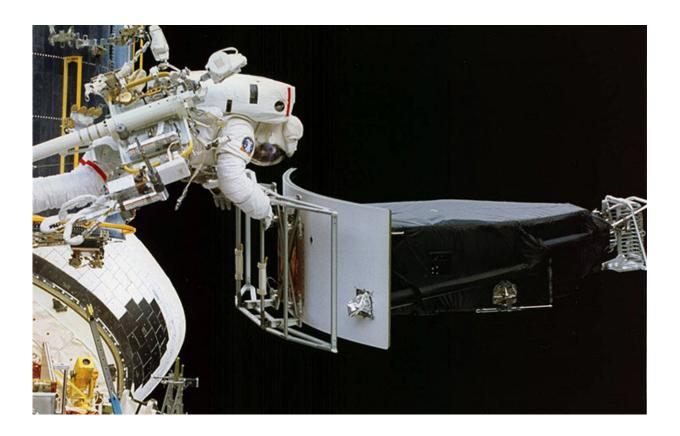
Astronaut Jeffrey Hoffman removes the Wide Field and Planetary Camera 1 (WFPC 1) during the first Hubble servicing mission (SM1), which took place in December 1993. Credit: NASA

On the sixth day of the mission, astronauts Jeffrey Hoffman and Story Musgrave conducted a spacewalk to remove WFPC from Hubble and install WFPC2. Everything seemed to go as planned, but the real test was yet to come.

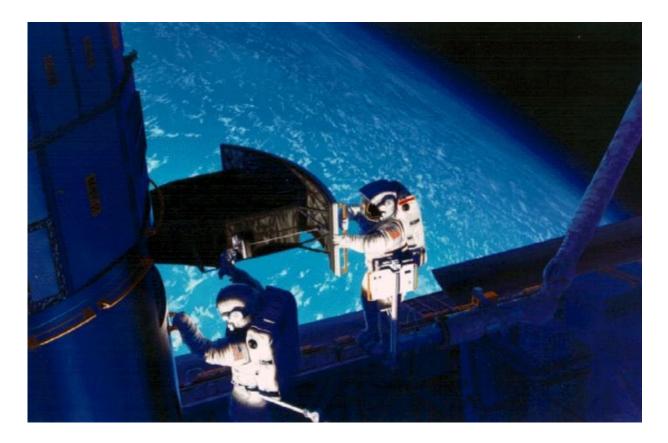
Astronauts Jeffrey Hoffman and Story Musgrave install the Wide Field and Planetary Camera 2 (WFPC2) on the Hubble Space Telescope, during SM1 in December 1993. Credit: NASA

To minimize the chance for error during WFPC2's installation in low-Earth orbit, the seven astronauts who were scheduled to execute the repair mission traveled to JPL to learn about the instrument and be trained on how to install it. They would be inserting WFPC2 into a cavity in the telescope's body, as if sliding it in a drawer. And although they would need to make sure that the electrical connections at the back of the instrument were secure, they had no way of reaching those connections; they could control only how they inserted the instrument.
