# A fire-breathing dragon helps fight ember attacks on thatched-roof buildings

December 17 2018

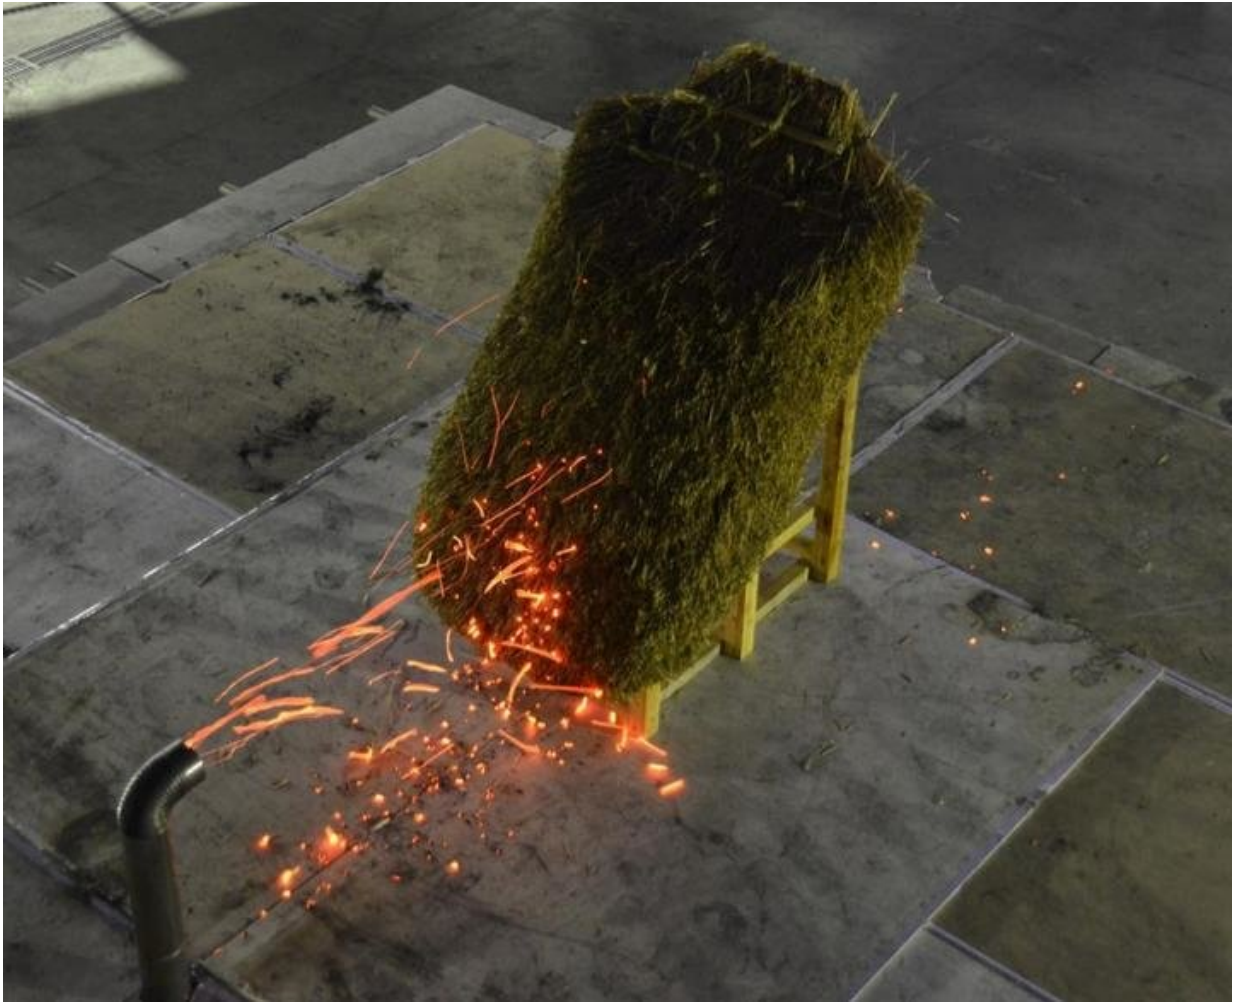
NIST Dragon (lower left) showering firebrands (embers) onto a model of a water reed thatched roof. Credit: NIST

To better understand the mechanisms by which firebrands—the airborne, glowing embers released by an outdoor [fire](#)—can ignite a thatched roof, NIST mechanical engineer Samuel Manzello and research scientist Sayaka Suzuki of Japan's National Research Institute of Fire and Disaster (NRIFD) used the NIST Firebrand Generator, nicknamed the NIST Dragon, to shower continuous streams of firebrands upon 1.1-meter-by-0.9-meter (3.6-foot-by-3-foot) roof mockups made from water reed, bamboo and wood.

Due to the continual shower of firebrands from the Dragon, multiple glowing firebrands reached the thatched-roof mockup. These accumulated on the surface, primarily near the bottom of the structure, with ignition occurring on average within 90 seconds. Once ignited, the fires progressed rapidly. Within 20 seconds of initial combustion in the majority of tests, flames reached the top of the roofing assembly and penetrated completely through it.
