Post-wildfire step-pool streams

April 4 2019

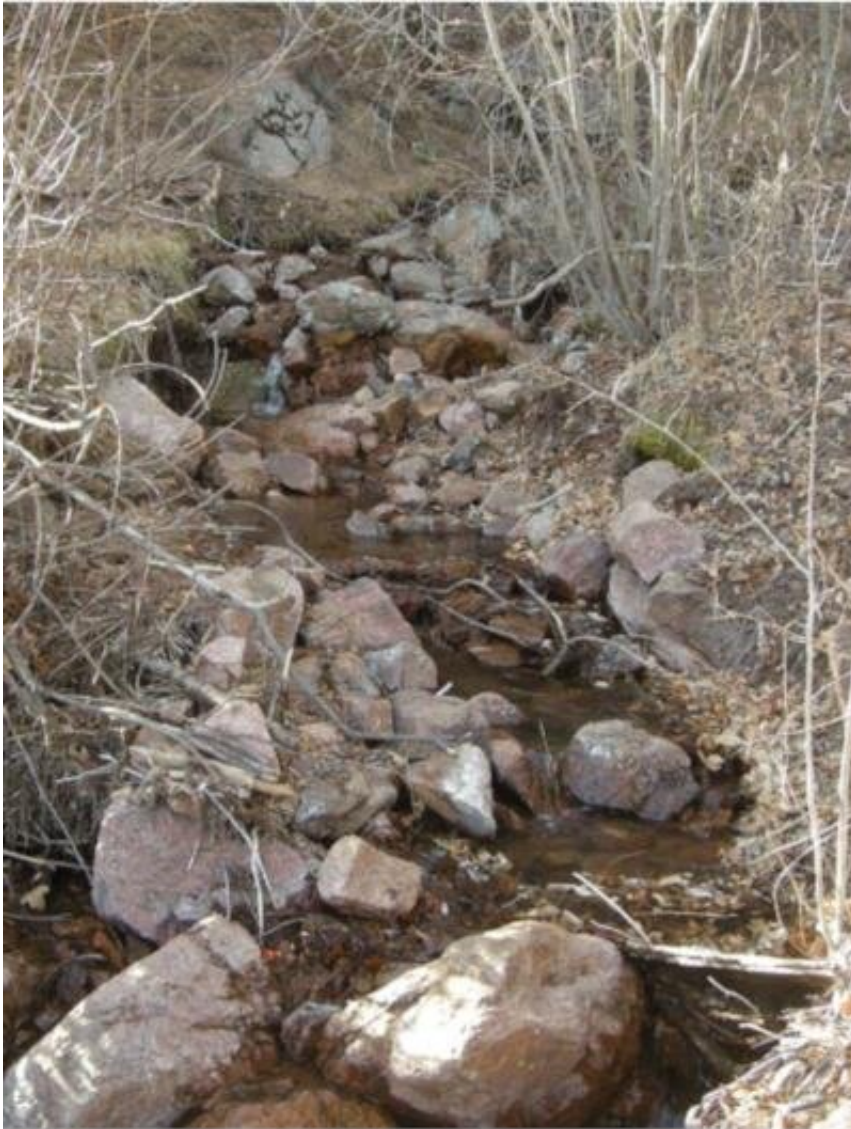
Step-pool sequences in Pike National Forest, Colorado, USA. (Academy study reach; photo taken on Dec. 12, 2014.) Credit: Anne Chin and colleagues, Geological Society of America Bulletin.
