Microorganisms protect iron sheet piling against degradation

August 27 2019

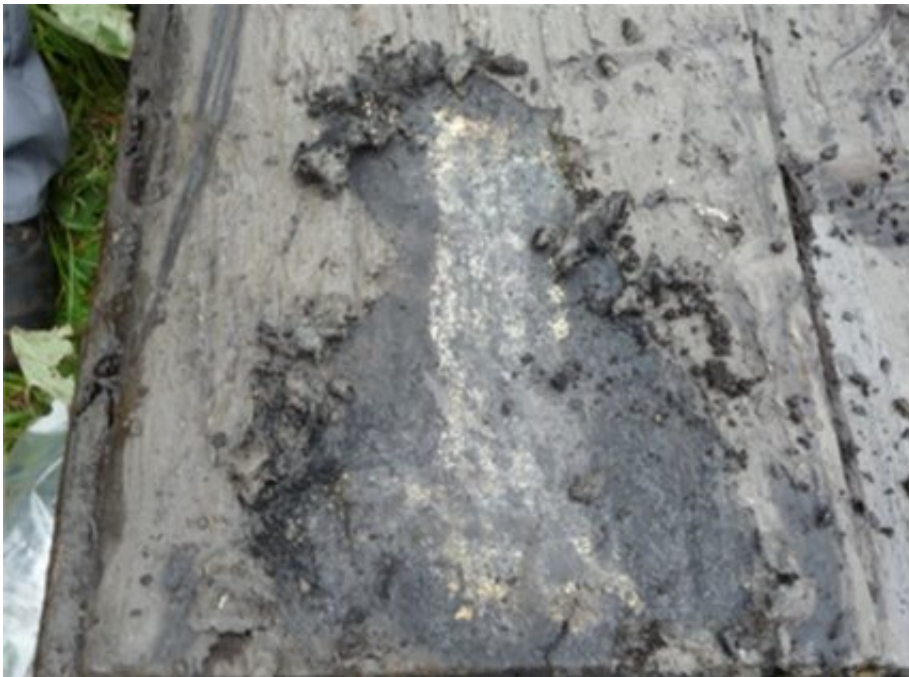
The biofilm on iron sheet piles. Credit: Radboud University

A natural biofilm of oxygen-free microorganisms protects iron sheet piling against corrosion by depositing minerals on the wall. That is what researchers at the Radboud University, the Dutch Institute of Ecology (NIOO-KNAW) and Deltares have published in *Applied and Environmental Microbiology*.

At the same time though, there are also places where the sheet piling is still in excellent condition. It appears that a natural protective layer has formed on the sheet piling, a biofilm consisting of minerals and [anaerobic microorganisms](#).

The microbiologists examined the biofilm on the sheet piling in Gouderak, in the Dutch province of Zuid-Holland. Using modern DNA sequencing methods, they identified the [microorganisms](#) that were present in the biofilm. Four types of oxygen-free or anaerobic microorganisms were found in the biofilm, including methane-producing microbes.

But what these microorganisms did exactly, remained unclear. That is why Michiel in 't Zandt started researching the existing literature. "We know that when [iron](#) comes into contact with water, slight corrosion occurs. During this process, hydrogen is formed. We now think that the methane-producing microorganisms use iron and hydrogen to convert [carbon dioxide](#), CO₂, into methane. And CO₂ largely determines the acidity of the sediment. If the CO₂ level lowers, the sediment becomes more alkaline. As a result, minerals precipitate, and the [protective layer](#) is created," in 't Zandt explains.
