NASA map reveals a new landslide risk factor

October 21 2019, by Esprit Smith

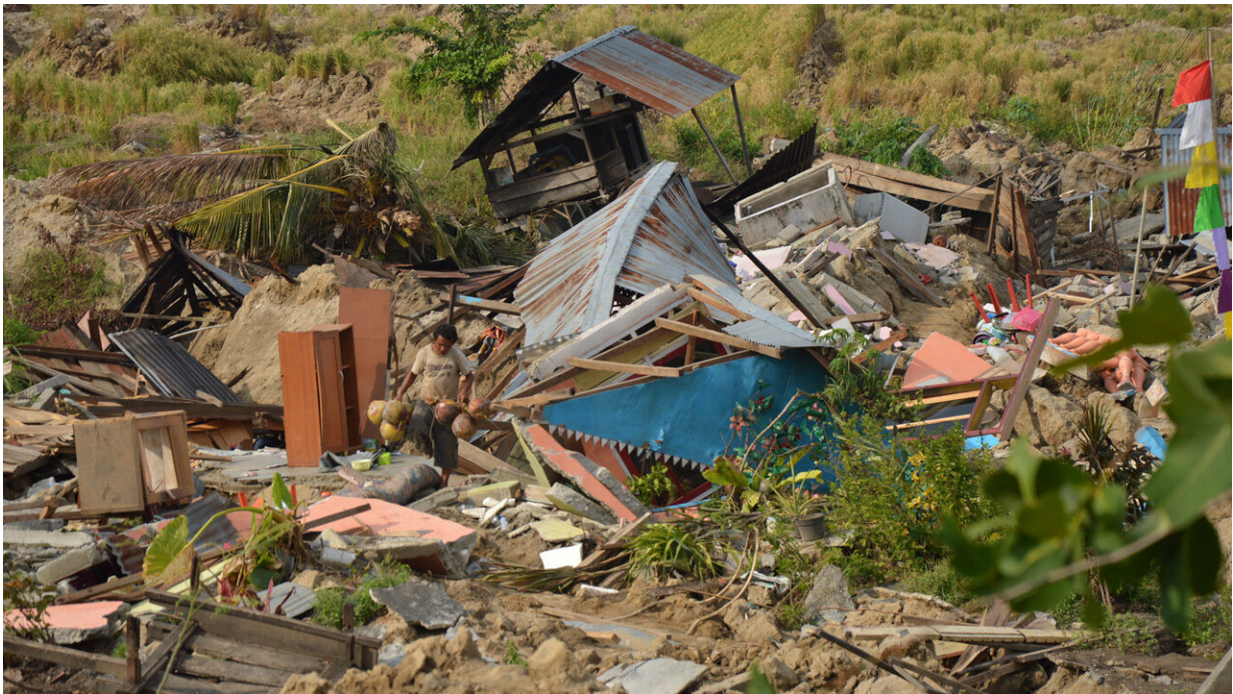
A man retrieving coconuts from a home destroyed by landslides, with damaged rice paddies in the background. Credit: European Union/Pierre Prakash, CC BY-NC-ND 2.0

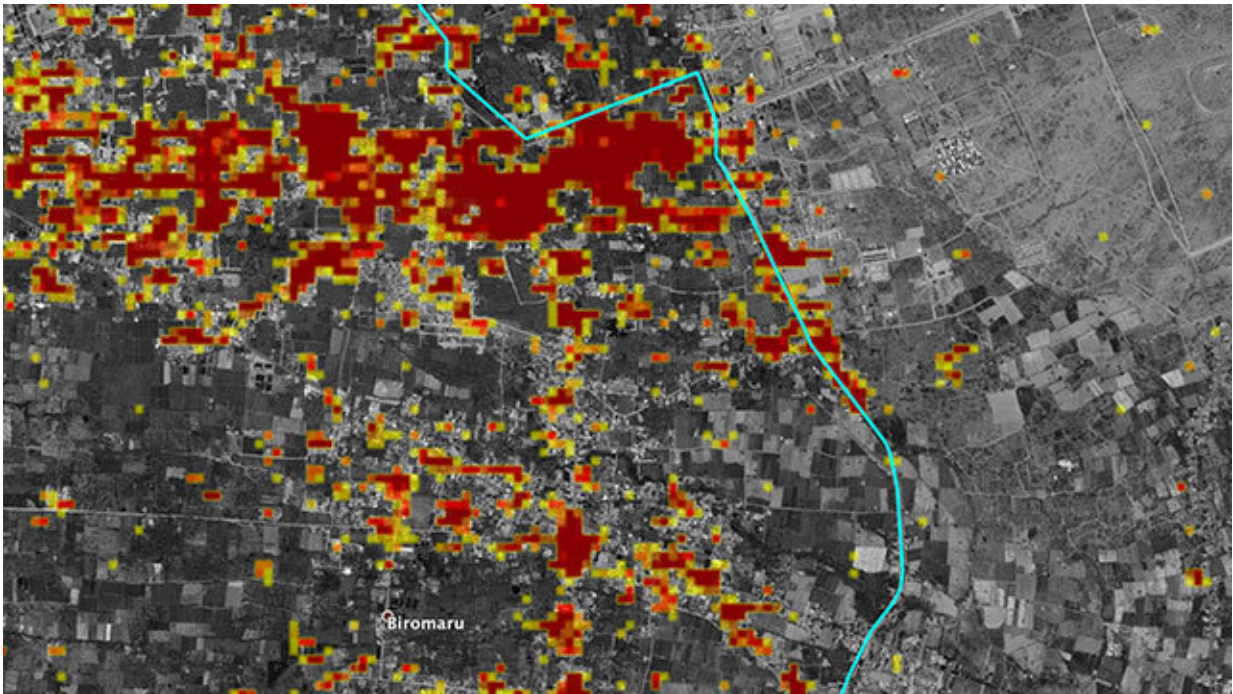
JPL's ARIA team produced this Damage Proxy Map of Palu after the 2018 earthquake. The aqueduct is marked in blue; red and yellow pixels show likely damage. The terrain slopes uphill from left to right, with major damage below the aqueduct and little above it. Credit: NASA/JPL-Caltech/JAXA

They were startled to notice that all the landslides originated along a distinct line. When they took a closer look, they saw that the line was an [aqueduct](#). "So we started studying why the aqueduct is clearly defining the boundary between land sliding and no sliding," Yun said.

Damage maps revealed widespread liquefaction below the aqueduct. Multiple slides carried some six square miles (16 square kilometers) of land far downhill—in some places farther than 49 feet (15 meters). The slides were slowed or halted by the coconut palm plantations. No liquefaction was identified uphill of the aqueduct.
