NASA InSight's 'Mole' is out of sight

October 19 2020, by Andrew Good

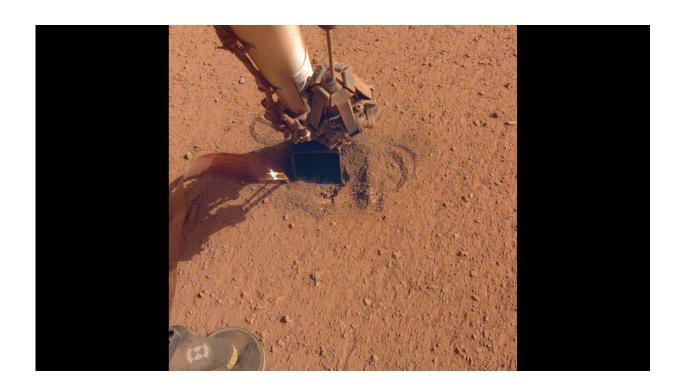
NASA's InSight retracted its robotic arm on Oct. 3, 2020, revealing where the spike-like "mole" is trying to burrow into Mars. The copper-colored ribbon attached to the mole has sensors to measure the planet's heat flow. In the coming months, the arm will scrape and tamp down soil on top of the mole to help it dig. Credit: NASA/JPL-Caltech

NASA's InSight lander continues working to get its "mole"—a 16-inchlong (40-centimeter-long) pile driver and heat probe—deep below the surface of Mars. A camera on InSight's arm recently took images of the now partially filled-in "mole hole," showing only the device's science

Sensors embedded in the tether are designed to measure heat flowing from the planet once the mole has dug at least 10 feet (3 meters) deep. The mission team has been working to help the mole burrow to at least that depth so that it can take Mars' temperature.

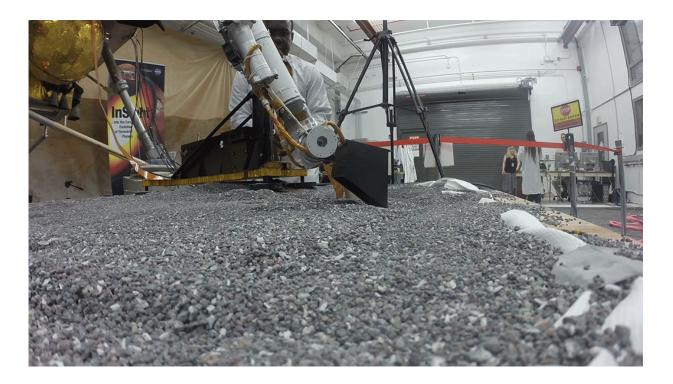
This footage from Aug. 19, 2019, shows a replica of InSight scraping soil with a scoop on the end of its robotic arm in a test lab at JPL. A replica of the "mole" - the lander's self-hammering heat probe - comes in to view as the scoop moves to the left. On Mars, InSight will scrape and tamp down soil on top of the mole to help it dig. Credit: NASA/JPL-Caltech

After the mole unexpectedly backed out of the pit while hammering last year, the team placed the small scoop at the end of the lander's <u>robotic arm</u> on top of it to keep it in the ground. Now that the mole is fully embedded in the soil, they will use the scoop to scrape additional soil on top of it, tamping down this soil to help provide more friction. Because it will take months to pack down enough soil, the mole isn't expected to resume hammering until early 2021.
