# Experts: Erosion caused Mexico sinkhole, not water pumping

July 5 2021

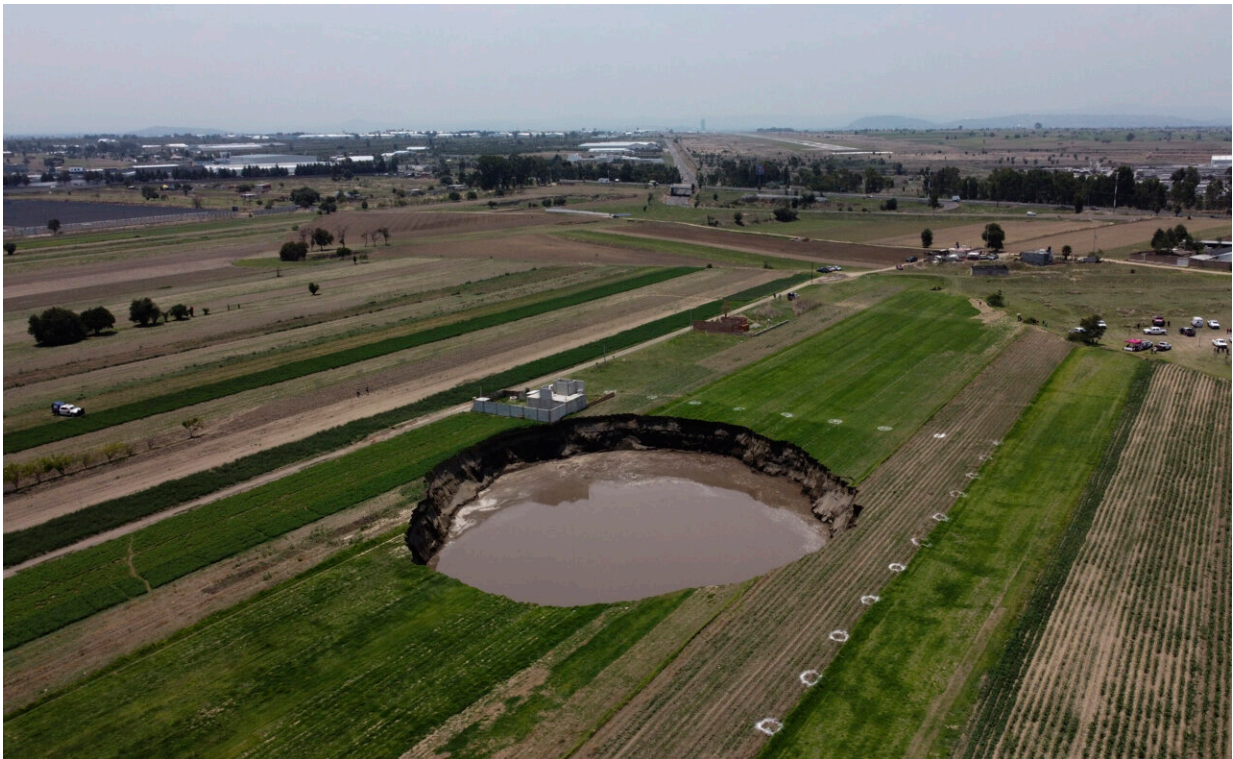
A water-filled sinkhole grows on a farming field in Zacatapec, on the outskirts of Puebla, Mexico, Tuesday, June 1, 2021. Authorities say an underground river is responsible. Credit: AP Photo/Pablo Spencer

A huge sinkhole that appeared in a farm in central Mexico in late May was caused by erosion of limestone bedrock and not excessive water pumping, a study by experts said Sunday

But Mexico's National Water Commission said the cause of the crater was "a natural process of limestone being dissolved," which can cause the soil on top to collapse. It said water table levels were stable and the aquifer was not over-exploited.

The bottom of the sinkhole is filled with water that appears to have strong currents, and experts say it is relatively warm, suggesting it comes from deep underground.

The sinkhole at the farm east of Mexico City has grown larger than a football field and swallowed a house. It also trapped two dogs that were rescued after several days on a ledge near the bottom of the 50-foot-deep (15-meter) hole.

The [sinkhole](#) is now over 400 feet (125 meters) across in some places, and may be 150 deep (45 meters) at its deepest point. It is hard to tell, because water fills much of the crater.
