# Dwindling water levels of Lake Powell seen from space

## Lake Powell elevation

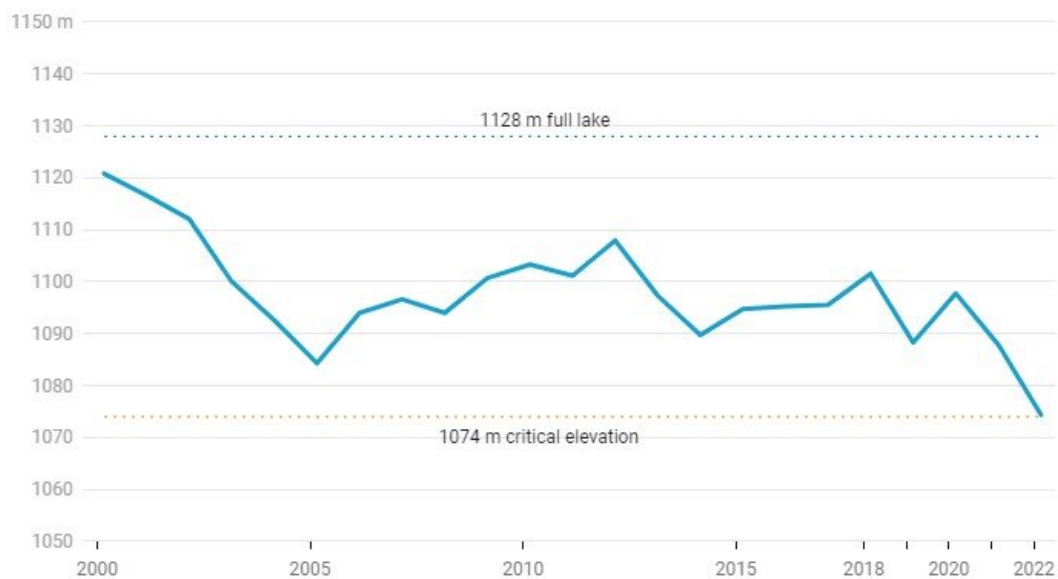
March average

The line graph shows the drastic drop in average [water levels](#) in March since 2000, when Lake Powell was at around 1,120 meters elevation. The current elevation is just a few meters from what is considered the "minimum power pool"—the level at which Glen Canyon Dam is able to generate hydroelectric power. If Lake Powell drops even more, it could soon hit a "deadpool" where water will likely fail to flow through the dam and onto the nearby Lake Mead.

In mid-March 2022, Lake Powell's elevation dropped to an astonishing 1,074 meters above sea level—the lowest the lake has been since it was filled in 1980. This drastic drop in water levels is documented in natural-color images captured by the Copernicus Sentinel-2 mission.
