What's next for Artemis I after 2nd scrub?

September 7 2022, by Richard Tribou, Orlando Sentinel

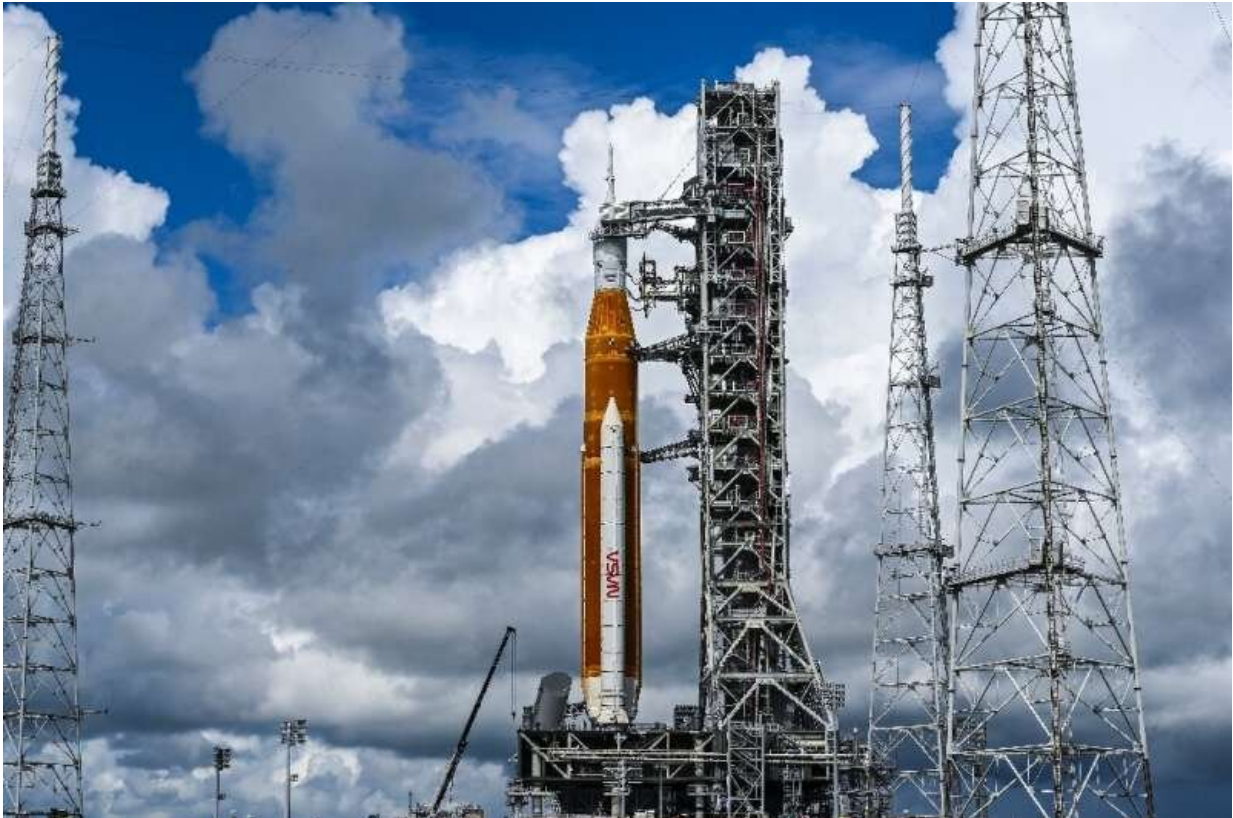
The Artemis I uncrewed lunar rocket sits on the launch pad at the Kennedy Space Center in Cape Canaveral, Florida, on August 25, 2022. Credit: NASA
