Landslides and law: Cyclone Gabrielle raises serious questions about where we've been allowed to build

February 21 2023, by Martin Brook

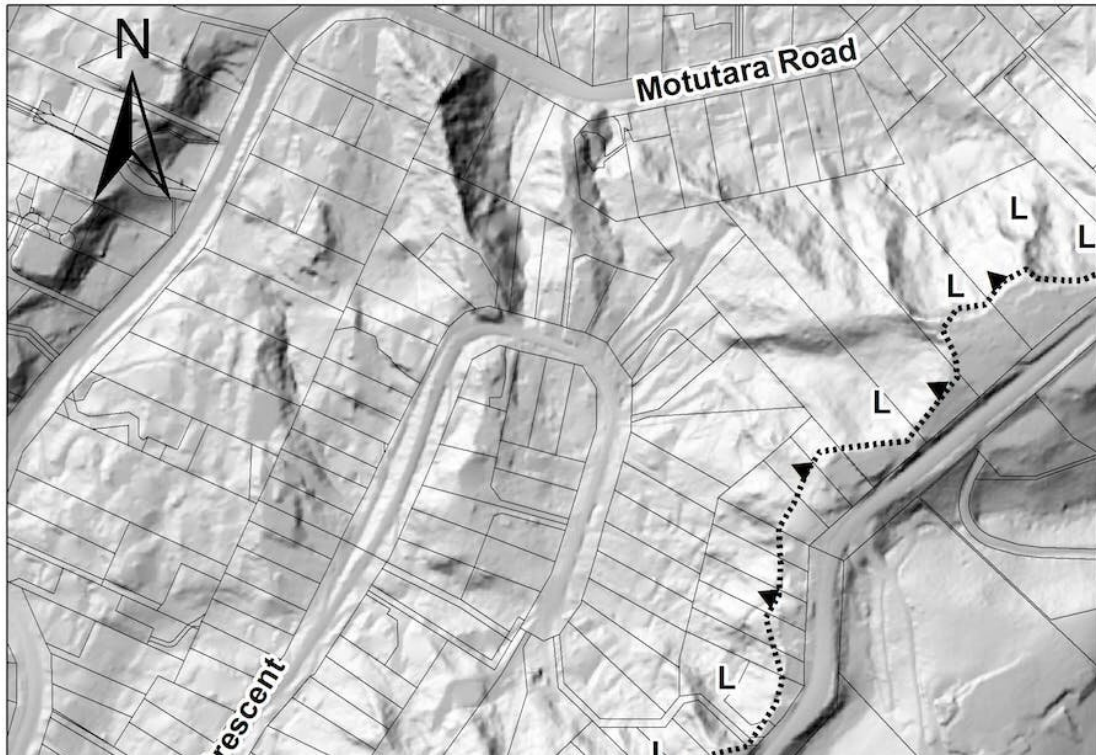
The figure below is a digital elevation model (DEM) based on 2016 data gathered by the remote-sensing method [LiDAR](#). This uses airborne laser scanning of the land surface, which removes vegetation and exposes the land surface "geomorphology" underneath.

This digital elevation model shows former landslides, roads and properties in Muriwai. Credit: Martin Brook

Landslides are denoted as "L." Houses on Domain Crescent and Motutara Road are at the foot of the escarpment, below landslide source areas. They are constructed on Kaihu sands, with some of the houses built on debris from former landslides.

In August 1965, following [heavy rainfall](#), fatal [landslides](#) over 200 meters long occurred on consecutive days at the south-east end of Domain Crescent, destroying houses and killing two people. The

landslide extent is denoted in red hash in the figure above.

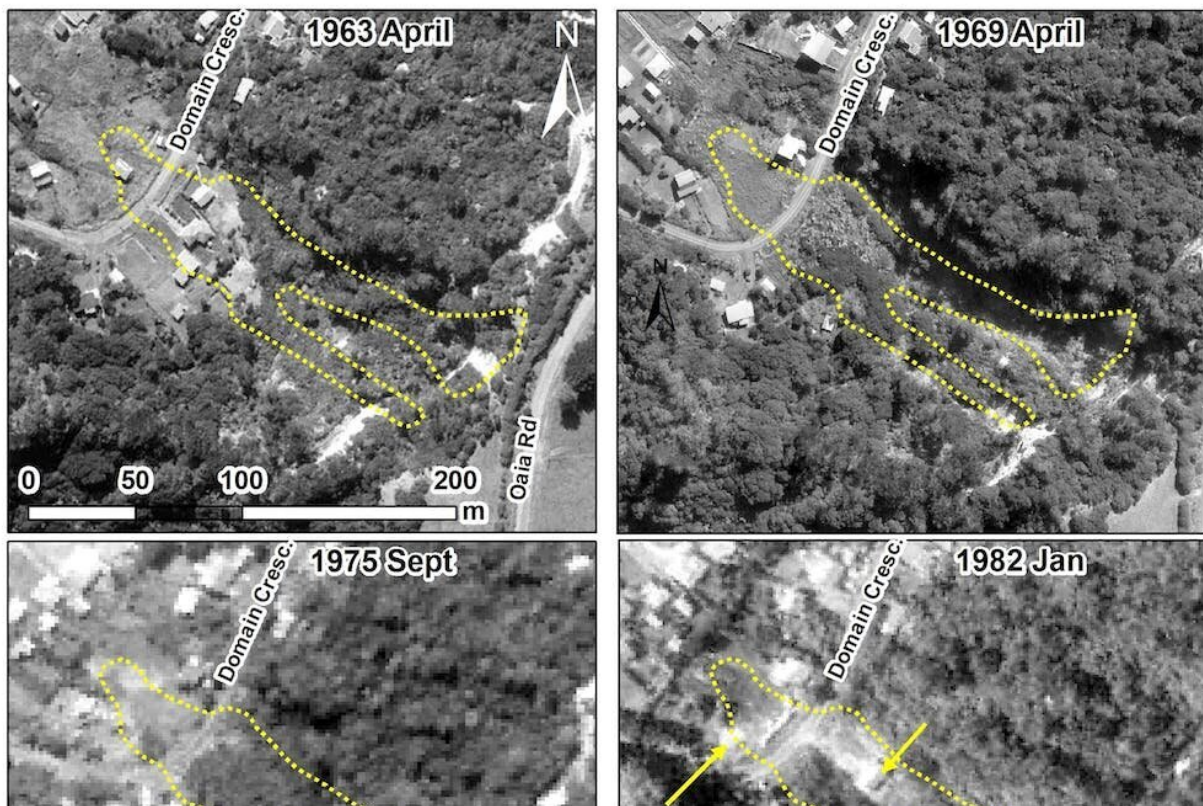
The timing of this new construction (denoted by the yellow arrows in the figure below) is intriguing. In 1981, the [Local Government Amendment Act](#) (section 641A) allowed councils to issue building permits for houses on unstable land prone to erosion, subsidence, slippage or inundation. Councils were also absolved of any civil liability.

This figure shows the extent of the 1965 landslide and where new homes were

built two decades later. Credit: Martin Brook
