# Flooding that closed Alaska's Dalton Highway also caused widespread ground sinking

October 12 2023, by Rod Boyce

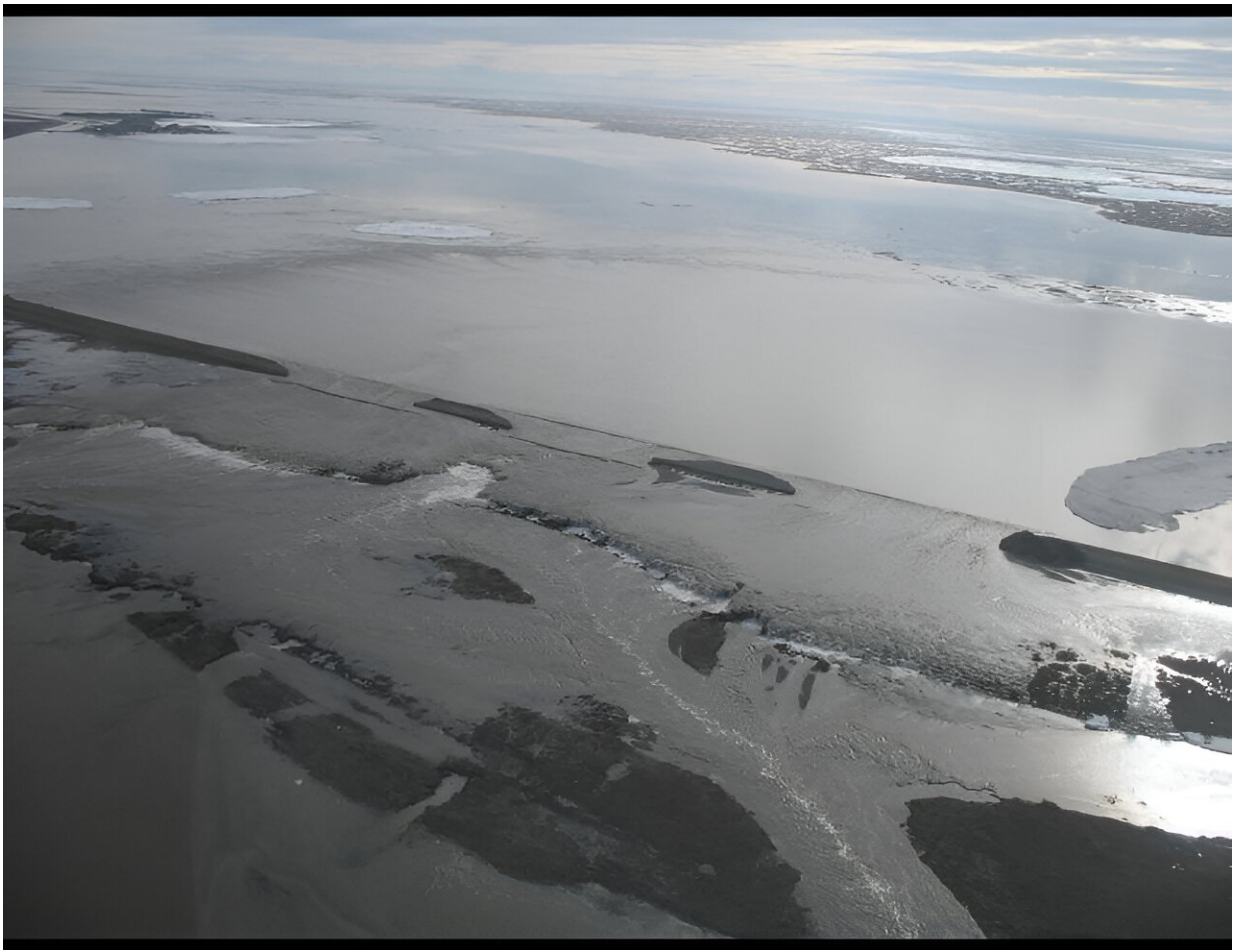
Floodwaters flow over and erode the Dalton Highway on May 21, 2015. The flooding contributed to the slow subsiding the ground in the permafrost-rich region. Credit: Alaska Department of Transportation and Public Facilities.

Floodwaters began spilling onto the Dalton Highway, Alaska's road to the North Slope, in mid-May 2015 and also reached Deadhorse airport. A pre-flood buildup of aufeis, layered ice that formed from the freezing of river water, is seen as the leading cause of the chaotic flooding. Aufeis diverted the thawing river's water away from natural channels.

The flood may have stimulated subsidence by warming the ground, causing ground ice to melt, the authors state. Warming can be due to increased wetness, disturbance to the protective layer of organic matter or [sediment deposition](#), allowing more heat to penetrate.
