Engineers facilitate the restoration of lake deltas

March 6 2024, by Rebecca Mosimann

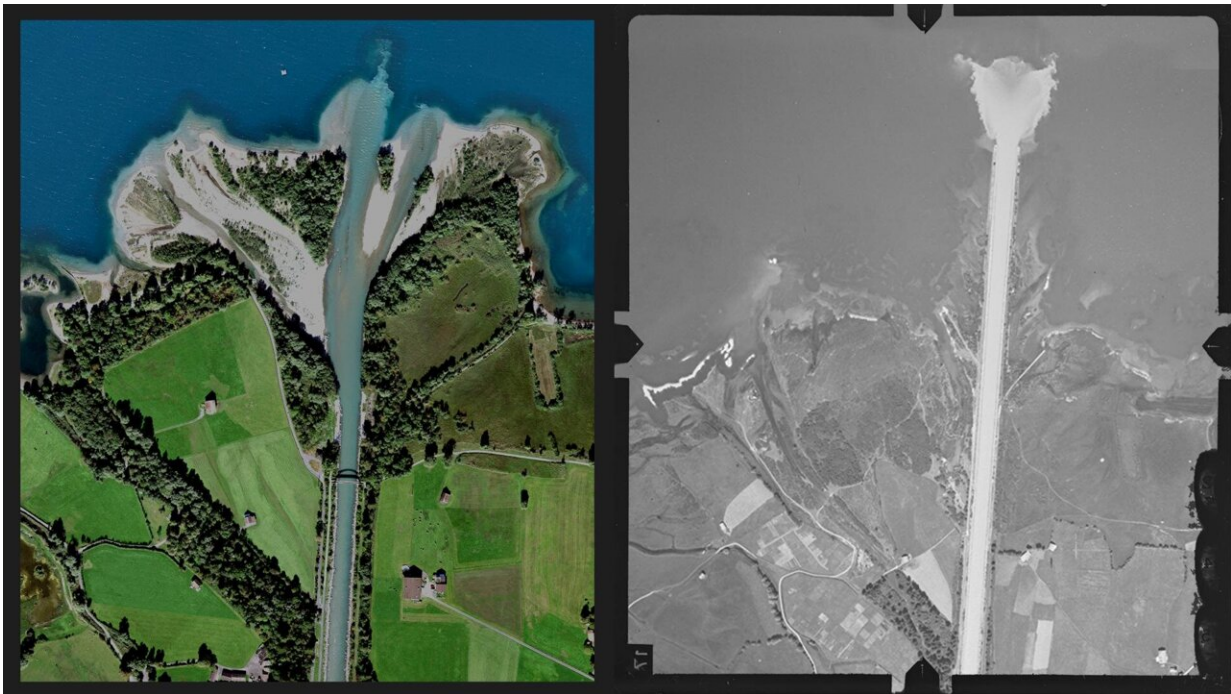
The evolution of the Reuss delta on the edge of Lake Lucerne between 2022 and 1937. Credit: Swisstopo

These images enabled the engineers to travel back in time and see the changes in river deltas following successive development projects. For instance, in 1850 the Reuss delta had an 85-degree opening angle, but as levees were built and other forms of anthropization occurred, the delta morphed into a straight line. An initial restoration project was completed in the 1990s, giving the river much more space.

Today, the [delta](#) has an opening angle of 60 degrees. "This [case study](#) shows experts how they can restore deltas to as close as possible to their original state while taking into account modern-day constraints associated with population growth, urban development and farming near the river mouth," says De Cesare.
