Cracks found in shuttle fuel tank, not just foam (Update)

10 November 2010, By MARCIA DUNN , AP Aerospace Writer

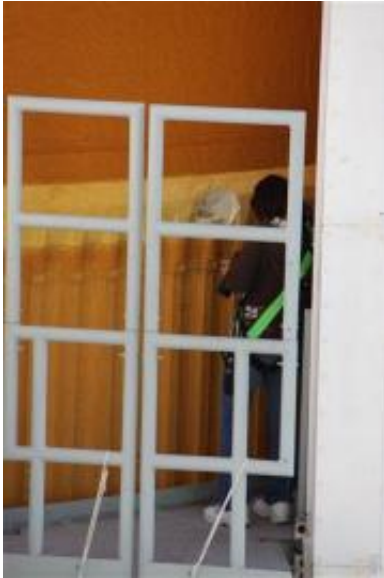
In this picture made available by NASA, a technician examines the area of the space shuttle Discovery's external tank where foam was removed to study the source a cracks on the tank in Cape Canaveral, Fla. on Wednesday, Nov. 10, 2010. (AP Photo/NASA, Troy Cryder)

The two cracks - each 9 inches long - were found on the exterior of the aluminum tank, beneath a larger crack in the insulating foam that covers the 15-story tank. The cracks are in an area that holds instruments, not fuel.

The cracks in the ribbed section of the tank - the so-called central intertank region - were discovered as workers removed pieces of the damaged foam for analysis. This region joins the upper oxygen and lower hydrogen chambers that make up the rust-colored tank.

NASA spokesman Allard Beutel said engineers believe the tank can be repaired at the launch pad, although it's never been tried before. It's unclear, though, whether the work can be done in time to meet a Nov. 30 launch attempt.

Similar cracks have been fixed before at the tank production facility in New Orleans, Beutel said. But the work has never been attempted at Kennedy Space Center, least of all on the launch pad. He said engineers are looking at what it would take to fix the tank at the pad.
