# Mars rover Curiosity prepares for test drive (Update)

August 21 2012, by ROBERT JABLON

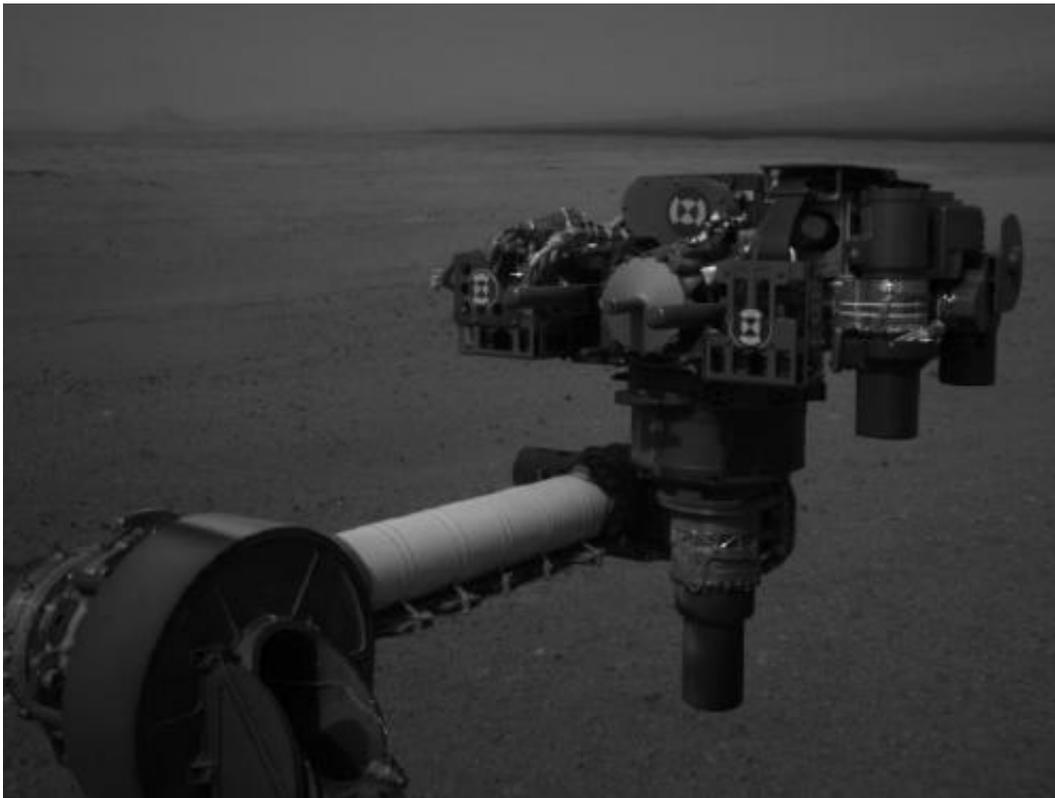
This full-resolution image from NASA's Curiosity shows the turret of tools at the end of the rover's extended robotic arm on Aug. 20, 2012. The Navigation Camera captured this view. Image credit: NASA/JPL-Caltech

Scientists also continued to test and calibrate Curiosity's 7-foot (2.1-meter)-long arm and its extensive tool kit — which includes a drill, a scoop, a spectrometer and a camera — in preparation for collecting its first soil samples and attempting to learn whether the Martian environment was favorable for microbial life.

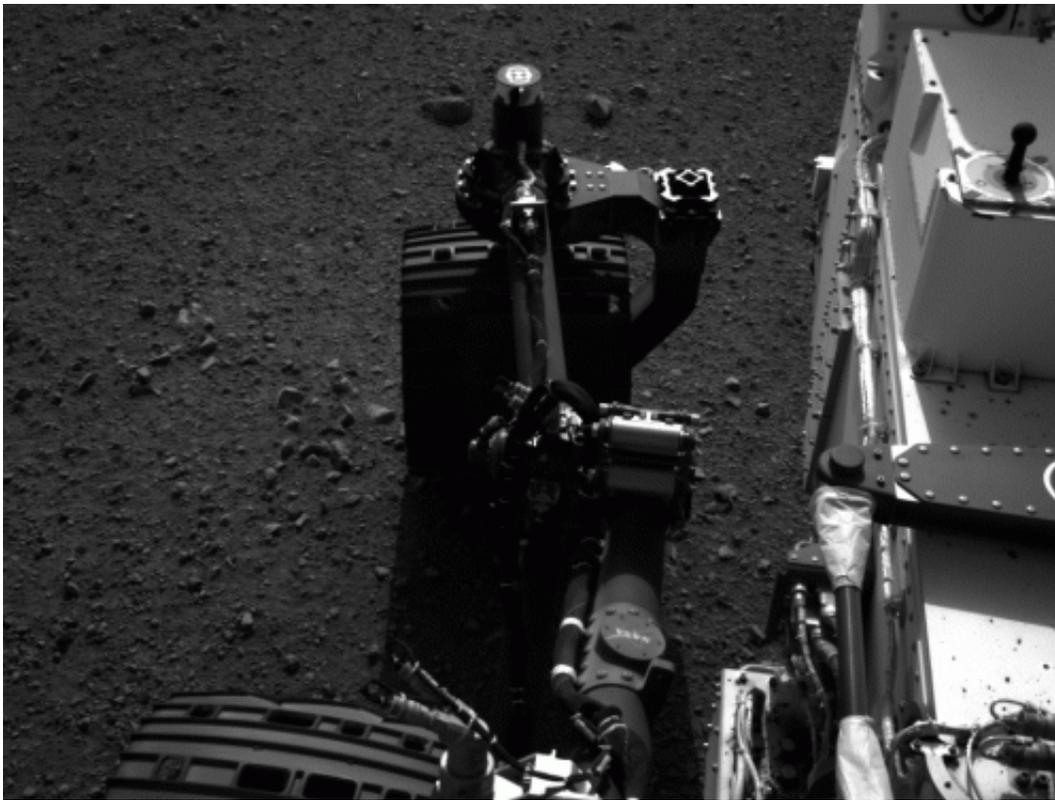
(CLICK ENLARGE) This set of images shows the movement of the rear right wheel of NASA's Curiosity as rover drivers turned the wheels in place at the landing site on Mars. Engineers wiggled the wheels as a test of the rover's steering and anticipate embarking on Curiosity's first drive in the next couple of days. This image was taken by one of Curiosity's Navigation cameras on Aug. 21. Image credit: NASA/JPL-Caltech

Engineers at NASA's Jet Propulsion Laboratory in Pasadena turned four of the rover's six wheels in place this week in a successful "wheel wiggle" to test the steering for Wednesday's trek, mission manager Mike Watkins said.

The rover will move forward about 10 feet (3 meters), turn right, then back up and park slightly to the left of its old spot, Watkins said.

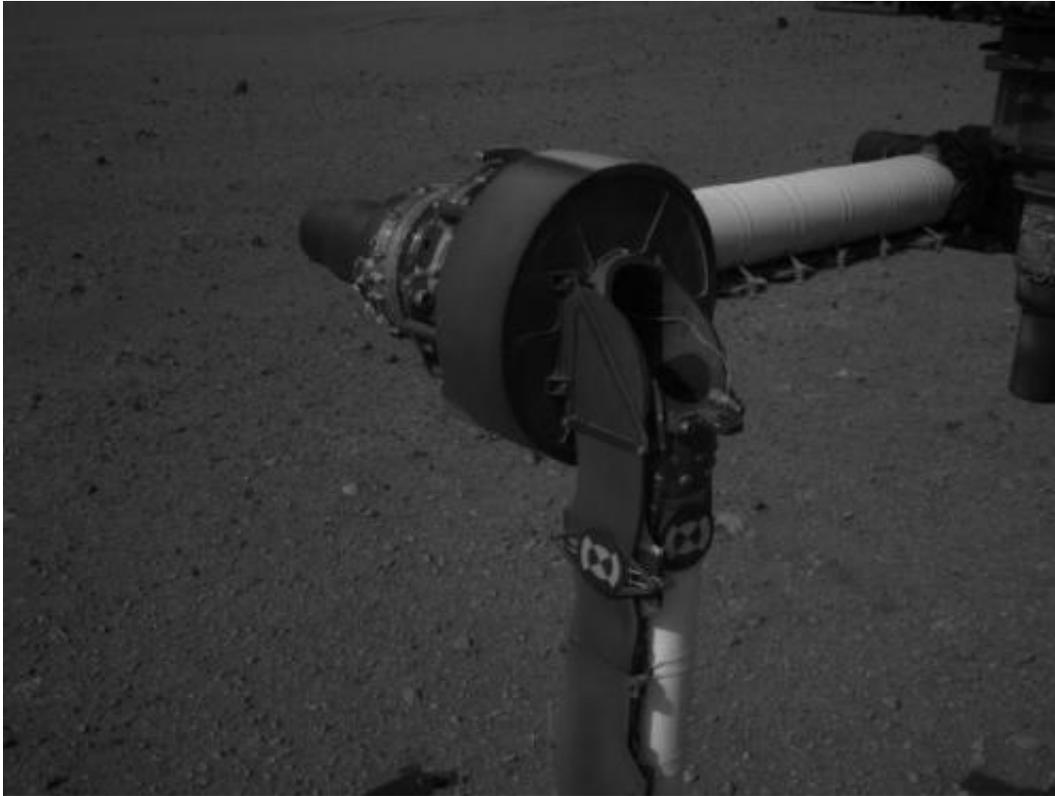
This full-resolution image from NASA's Curiosity shows the elbow joint of the rover's extended robotic arm on Aug. 20, 2012. The Navigation Camera captured this view. Image credit: NASA/JPL-Caltech
