Mars rover Curiosity prepares for test drive (Update)

21 August 2012, by ROBERT JABLON

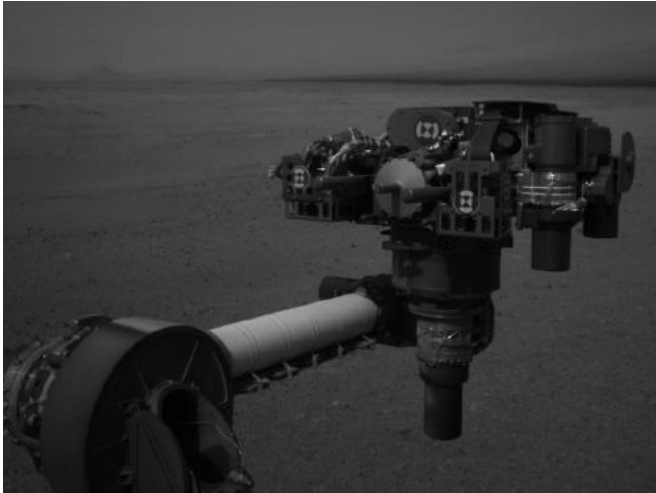
This full-resolution image from NASA's Curiosity shows the turret of tools at the end of the rover's extended robotic arm on Aug. 20, 2012. The Navigation Camera captured this view. Image credit: NASA/JPL-Caltech

Scientists also continued to test and calibrate Curiosity's 7-foot (2.1-meter)-long arm and its extensive tool kit - which includes a drill, a scoop, a spectrometer and a camera - in preparation for collecting its first soil samples and attempting to learn whether the Martian environment was

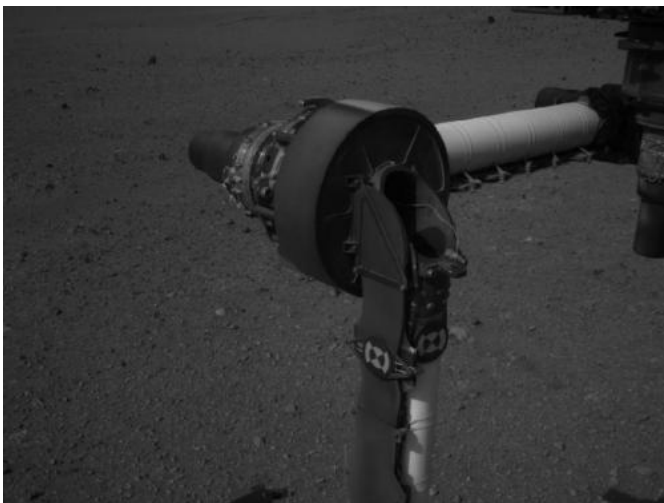
This full-resolution image from NASA's Curiosity shows the elbow joint of the rover's extended robotic arm on Aug. 20, 2012. The Navigation Camera captured this view. Image credit: NASA/JPL-Caltech
