Curiosity Mars rover finds sandstone variations

25 March 2014, by Guy Webster

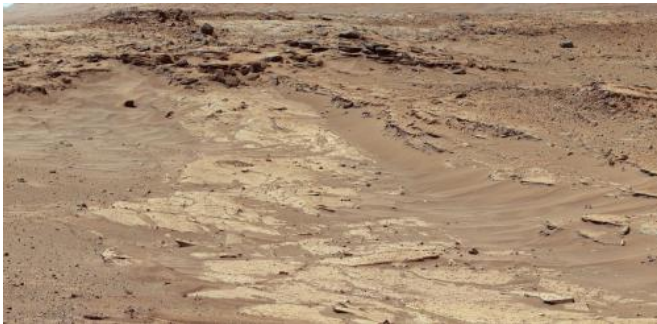
Sandstone layers with varying resistance to erosion are evident in this Martian scene recorded by the Mast Camera on NASA's Curiosity Mars rover on Feb. 25, 2014, about one-quarter mile (about 400 meters) from a planned waypoint called "the Kimberley." Credit: NASA/JPL-Caltech/MSSS

"A major issue for us now is to understand why some rocks resist erosion more than other rocks, especially when they are so close to each other and are both likely to be sandstones," said Michael Malin of Malin Space Science Systems, San Diego. He is the principal investigator for the Mast Camera and the Mars Descent Camera on Curiosity.

As in the southwestern United States, understanding why some [sandstones](#) are harder than others could help explain the major shapes of the landscape where Curiosity is working inside Gale Crater on Mars. Erosion-resistant sandstone forms a capping layer of mesas and buttes. It could even hold hints about why Gale Crater has a large layered mountain, Mount Sharp, at its center.

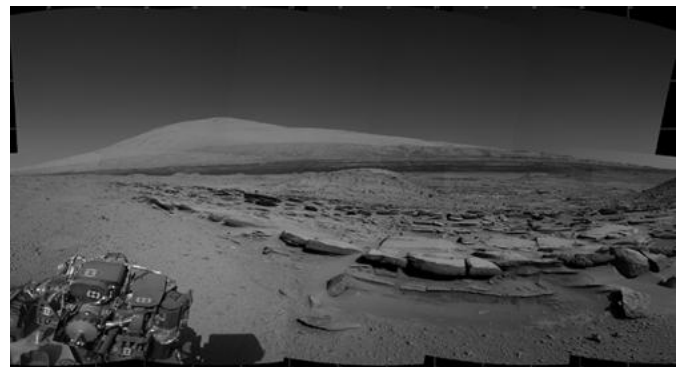
This view from NASA's Curiosity Mars rover spans 360 degrees, centered southward toward a planned science waypoint at "the Kimberley," with an outcrop of eroded sandstone in the foreground. Image Credit: NASA/JPL-Caltech
