What we know so far about problems at the tallest US dam

16 February 2017, by Paul Elias

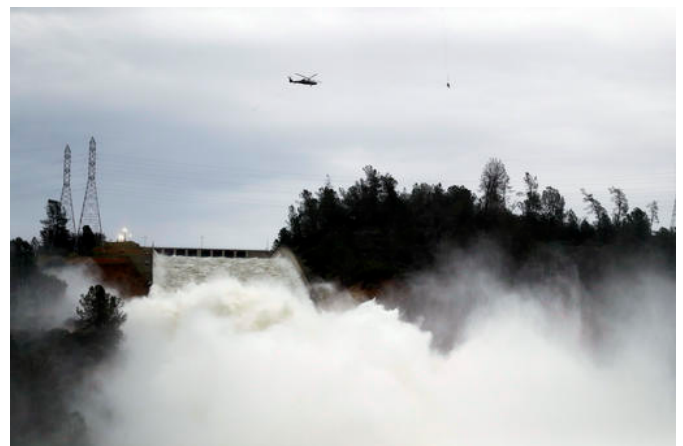
Water gushes down the Oroville Dam's main spillway Wednesday, Feb. 15, 2017, in Oroville, Calif. The Oroville Reservoir is continuing to drain Wednesday as state water officials scrambled to reduce the lake's level ahead of impending storms. (AP Photo/Marcio Jose Sanchez)

Engineers noticed an odd flow pattern on the main concrete spillway Feb. 7 and shut off the water to investigate. They discovered a large crater in the bottom.

Despite heavy rain and melting snow, engineers slowed releases later in the week after the hole grew. Compounding matters, concrete from the eroding hole clogged the power plant's exit channel and forced it to shut down.

The cause of the hole remains unknown. A report prepared Feb. 11 by a CalFire official suggested heavy rain may have contributed.

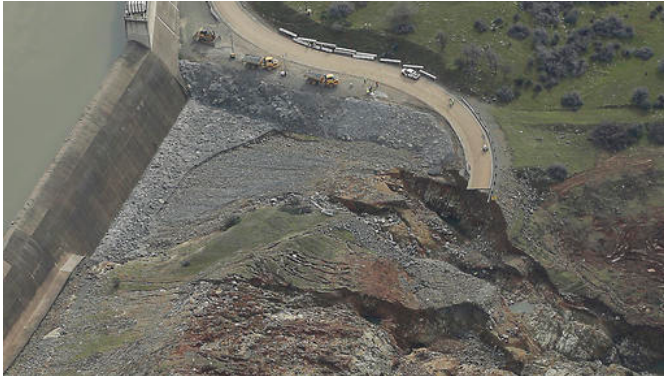
This photo taken Monday, Feb. 13, 2017, shows erosion caused when overflow water cascaded down the emergency spillway, right, of the Oroville Dam in Oroville, Calif. Water flowed over the emergency spillway Sunday morning when Lake Oroville reached capacity, and engineers determined the hillside was eroding faster than expected, undermining the concrete wall. Officials fearing it was about to collapse ordered thousands of residents downstream to evacuate. (AP Photo/Rich Pedroncelli)

A few hours later, engineers determined the hillside was eroding faster than expected, undermining the concrete wall. Officials feared it was about to collapse and cause a catastrophic flood.

Environmental groups demanded 12 years ago that the hillside be paved with concrete to prevent erosion. But federal regulators decided against ordering the work after state water agencies argued it would cost too much for a structure that, at that point, had never been used.

The emergency spillway also has been repaired enough to handle any overflow, Croyle said. Officials identified three areas where erosion caused the most concern of potential flooding, including one spot that was completely fixed, he said. The others were partially repaired.
