What we know so far about problems at the tallest US dam

February 16 2017, by Paul Elias

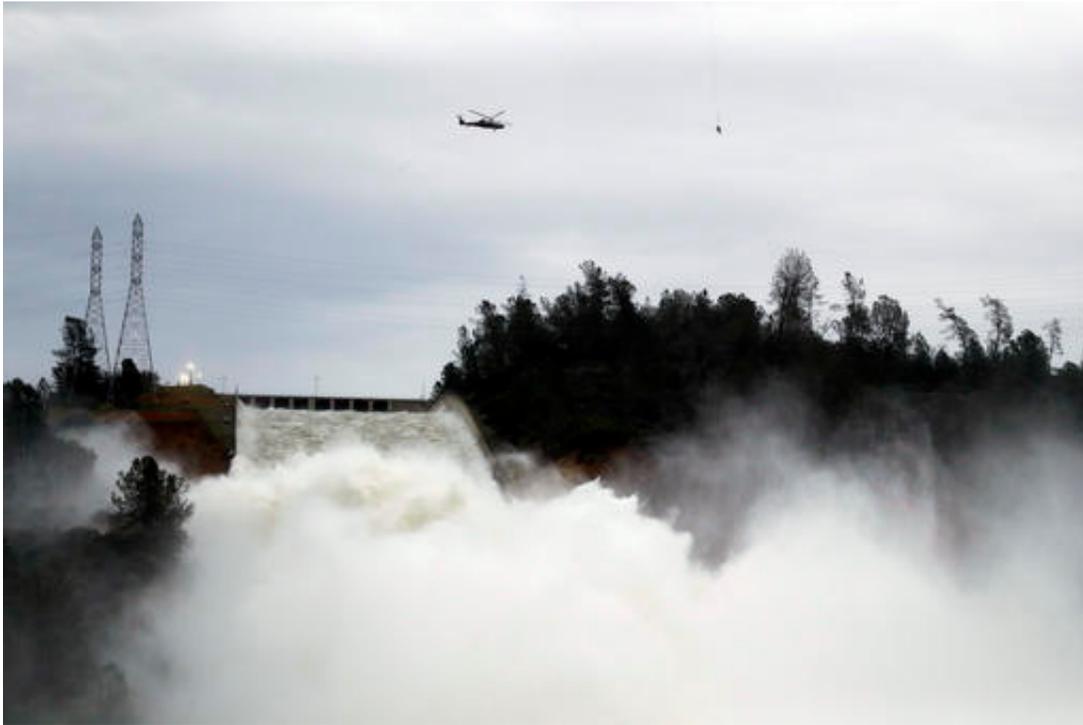
Water gushes down the Oroville Dam's main spillway Wednesday, Feb. 15, 2017, in Oroville, Calif. The Oroville Reservoir is continuing to drain Wednesday as state water officials scrambled to reduce the lake's level ahead of impending storms. (AP Photo/Marcio Jose Sanchez)

Engineers noticed an odd flow pattern on the main concrete spillway Feb. 7 and shut off the water to investigate. They discovered a large crater in the bottom.

Despite heavy rain and melting snow, engineers slowed releases later in the week after the hole grew. Compounding matters, concrete from the eroding hole clogged the power plant's exit channel and forced it to shut down.

Engineers determined the hole couldn't immediately be fixed and decided to keep using the damaged spillway with reduced flows. The next day, it rained harder than expected, and a day later, water was flowing in almost twice as fast as it was draining.

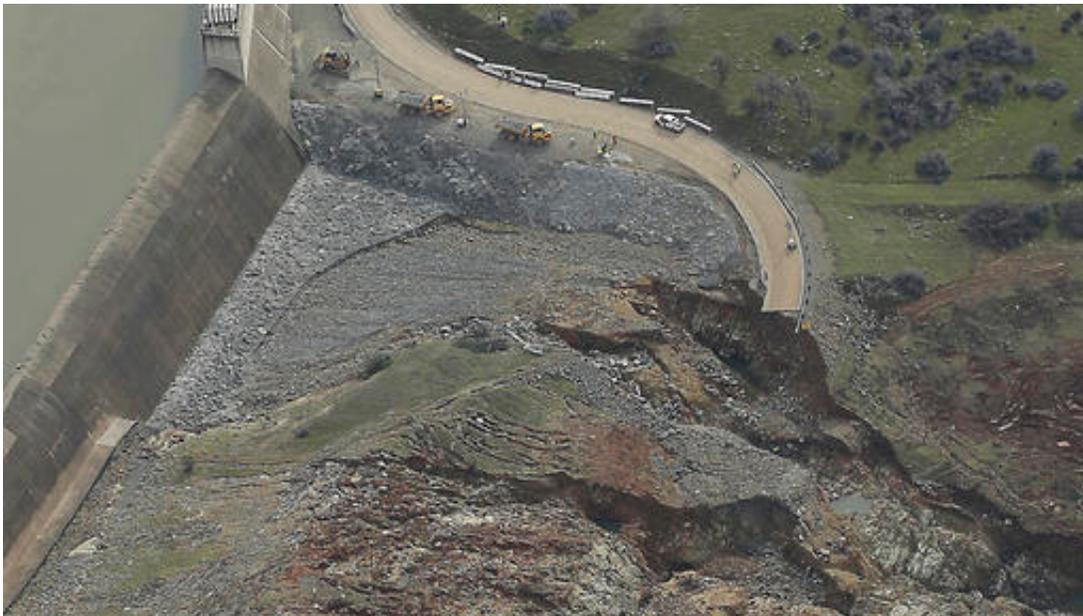
This photo taken Monday, Feb. 13, 2017, shows erosion caused when overflow water cascaded down the emergency spillway, right, of the Oroville Dam in Oroville, Calif. Water flowed over the emergency spillway Sunday morning when Lake Oroville reached capacity, and engineers determined the hillside was

eroding faster than expected, undermining the concrete wall. Officials fearing it was about to collapse ordered thousands of residents downstream to evacuate. (AP Photo/Rich Pedroncelli)

A few hours later, engineers determined the hillside was eroding faster than expected, undermining the concrete wall. Officials feared it was about to collapse and cause a catastrophic flood.

"I'm not sure anything went wrong," Department of Water Resources acting chief Bill Croyle said of the near-failure of the emergency spillway. "This was a new, never-happened-before event."

Environmental groups demanded 12 years ago that the hillside be paved with concrete to prevent erosion. But federal regulators decided against ordering the work after state water agencies argued it would cost too much for a structure that, at that point, had never been used.

The emergency spillway also has been repaired enough to handle any overflow, Croyle said. Officials identified three areas where erosion caused the most concern of potential flooding, including one spot that was completely fixed, he said. The others were partially repaired.
