Palcacocha icefalls demonstrate hazard vulnerabilities in Peru

June 13 2017, by Ben Orlove

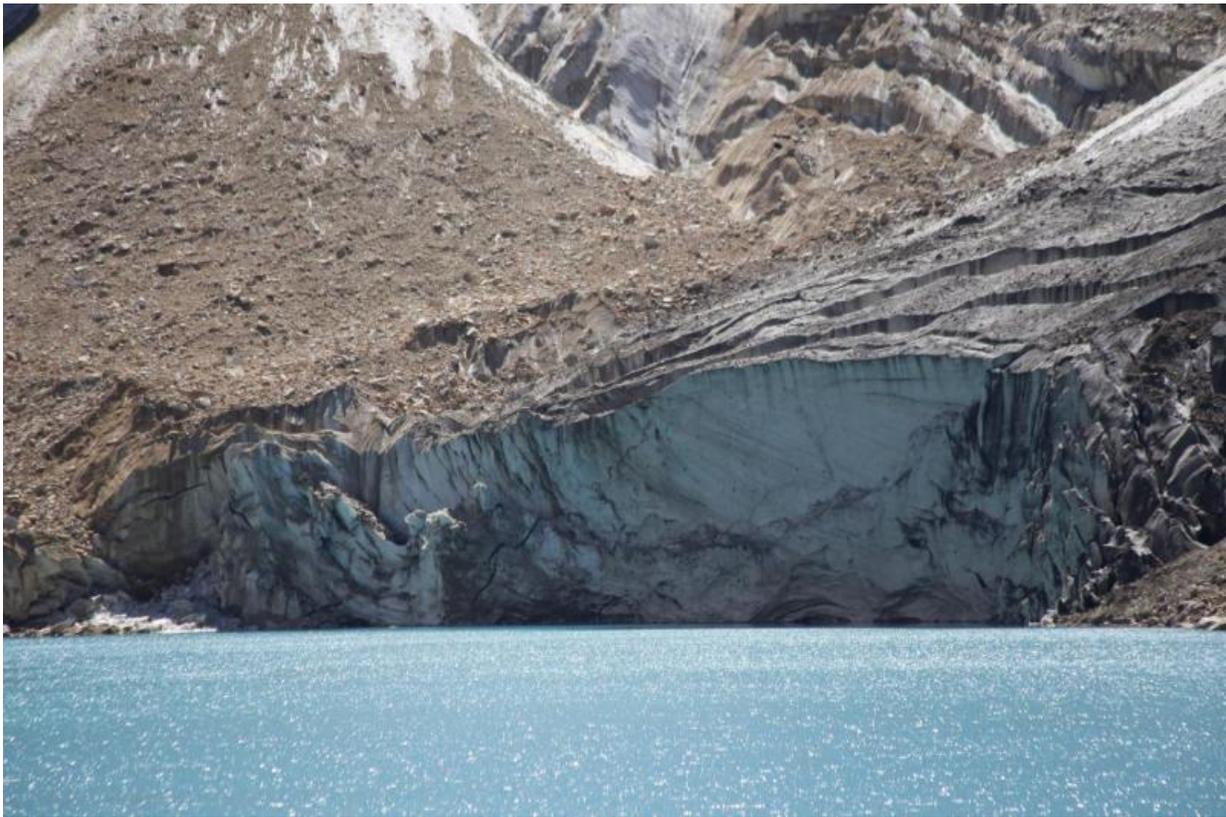
Glacier front subject to calving, Lake Palcacocha. Credit: Jeff Kargel

In the last week, calving events at Lake Palcacocha in the Peruvian Andes released masses of ice from a glacier on Mount Pucaranra. The ice fell into the lake, sending waves across the lake that destroyed

Jeff Kargel, a planetary scientist at the University of Arizona, told GlacierHub that both calving events and avalanches at Palcacocha "dump energy into the lake, and if they are large and sudden enough, a big wave can form. As with other more classical tsunamis, the shoaling in Palcacocha toward the south end of the lake— where the syphons are— can cause a relatively small displacement wave to build up to a much larger size when it nears the shore. Avalanches and calving events are frequent occurrences at this lake, and both should be especially active in the late May-July period, which tends to be the dry season, hence mainly sunny, thus allowing high solar radiation. The air temperature doesn't

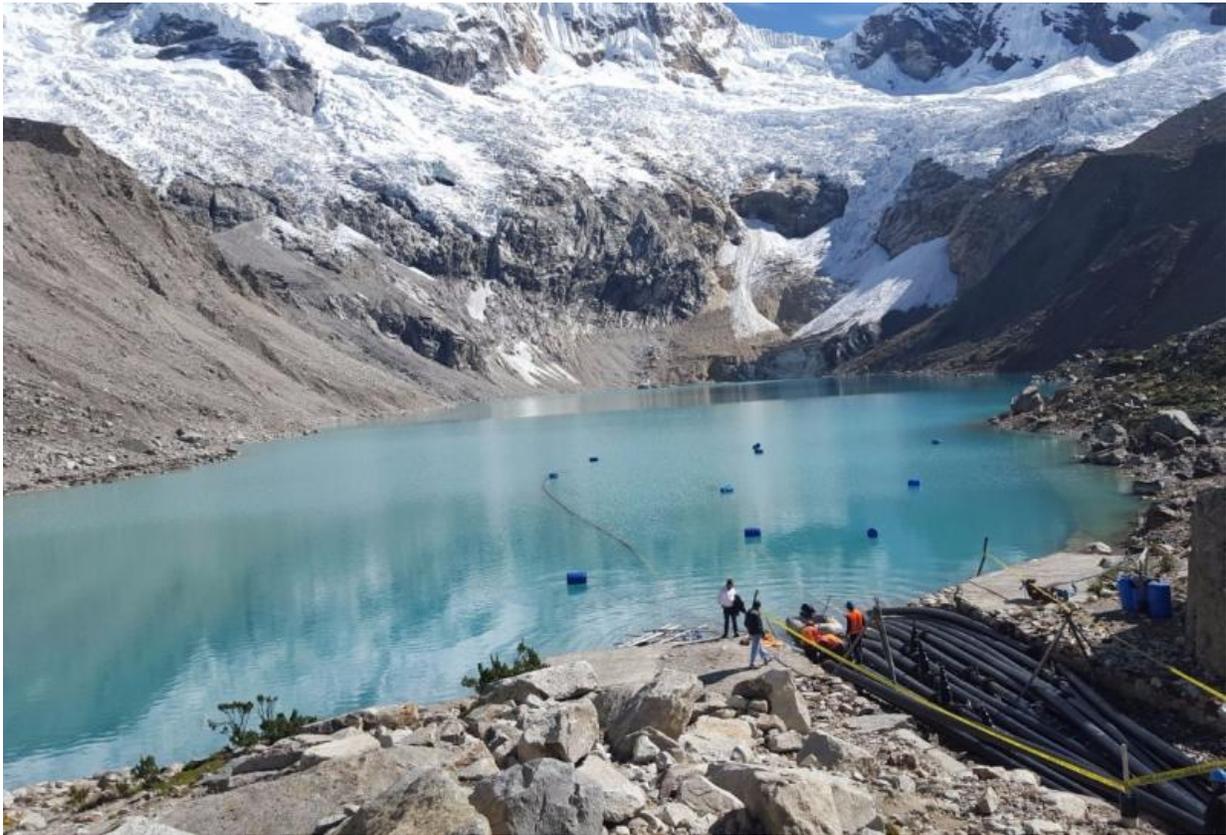
Pucaranra Glacier, Lake Palcacocha, and syphons at the moraine. Credit: INDECI

Zapata indicated that the calving event occurred around 8 p.m. on May 31. The resulting waves, three meters in height, were strong enough to move and damage ten large pipes, rendering them inoperable. These pipes, known locally as "syphons," are designed to draw water from the lake at times when its level is high; in this way, they were thought to reduce flood risk significantly. They had been a point of local pride, seen as a successful application of modern technology to protect against the dangers to which the region has long been subject.

Representatives of INAIGEM and two other organizations, the National Water Authority and the local municipality of Independencia, visited the lake a few days later. They found that the workers on Pucathe site had restored two of the drainage pipes. These officials anticipated that the other eight will soon be functional. Zapata and the other authorities

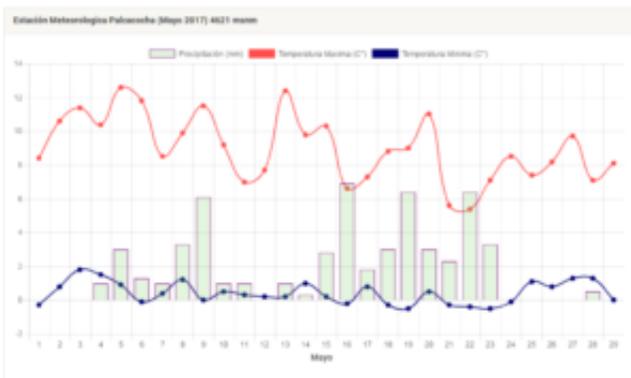
Weather data at Palcacocha, May 2017. Credit: INAIGEM

The weather data indicate some warm days in May at Palcacocha. The data also demonstrate that May had less rain than usual, particularly toward the end of the month. Such dry weather is typically associated with less cloud cover, supporting Kargel's suggestion and a report in a regional newspaper, Ancash Noticias, which stated that "intense solar radiation" in recent weeks had been the cause of the calving events. The data also support the observations of the local residents about the temperature fluctuations between day and night, since cloudless nights in this region are colder than ones with overcast skies.
