Palcacocha icefalls demonstrate hazard vulnerabilities in Peru

13 June 2017, by Ben Orlove

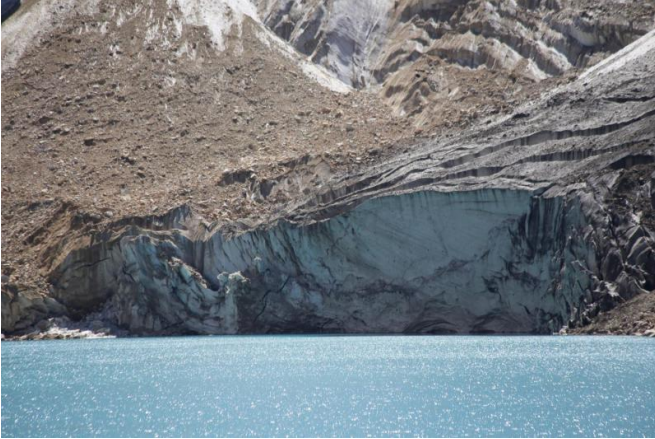
Glacier front subject to calving, Lake Palcacocha. Credit: Jeff Kargel

In the last week, calving events at Lake Palcacocha in the Peruvian Andes released masses of ice from a glacier on Mount Pucaranra. The ice fell into the lake, sending waves across the lake that destroyed infrastructure designed to prevent dangerous outburst floods. Fortunately, the waves were not high enough to overtop the moraine dam and send floodwaters downstream, where they could have taken many lives and damaged urban infrastructure. A glacial lake outburst flood from Palcacocha devastated Huaraz, the largest city in the region, in 1941, killing about 5,000 people. Other, more recent, glacier floods in the region have also been very destructive.

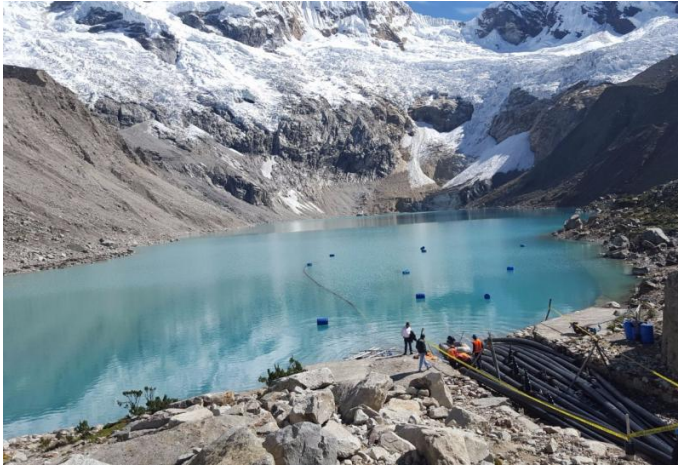
Pucaranra Glacier, Lake Palcacocha, and syphons at the moraine. Credit: INDECI

Zapata indicated that the calving event occurred around 8 p.m. on May 31. The resulting waves, three meters in height, were strong enough to move and damage ten large pipes, rendering them inoperable. These pipes, known locally as "syphons," are designed to draw water from the lake at times when its level is high; in this way, they were thought to reduce flood risk significantly. They had been a point of local pride, seen as a successful application of modern technology to protect against the dangers to which the region has long been subject.

Representatives of INAIGEM and two other organizations, the National Water Authority and the local municipality of Independencia, visited the lake a few days later. They found that the workers on Pucarthe site had restored two of the drainage pipes. These officials anticipated that the other eight will soon be functional. Zapata and the other authorities called for increased investment in infrastructure at the lake to reduce the risks of a flood. They estimated that an expenditure of US \$6 million would prevent about \$2.5 billion in potential damages, including a hydroelectric plant and irrigation facilities on Peru's desert coast; it would also protect the lives of the 50,000 people who live in the potential flood zone.

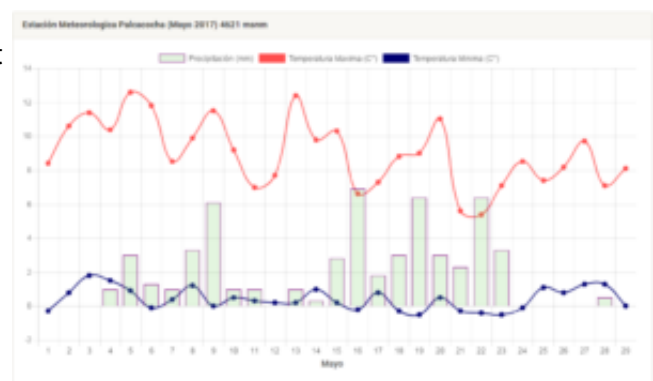
Weather data at Palcacocha, May 2017. Credit: INAIGEM

The weather data indicate some warm days in May at Palcacocha. The data also demonstrate that May had less rain than usual, particularly toward the end of the month. Such dry weather is typically associated with less cloud cover, supporting Kargel's suggestion and a report in a regional newspaper, *Ancash Noticias*, which stated that "intense solar radiation" in recent weeks had been the cause of the calving events. The data also support the observations of the local residents about the temperature fluctuations between day and night, since cloudless nights in this region are colder than ones with overcast skies.
