Engineers use replica to pinpoint California dam repairs

June 26 2017, by Brady Mccombs

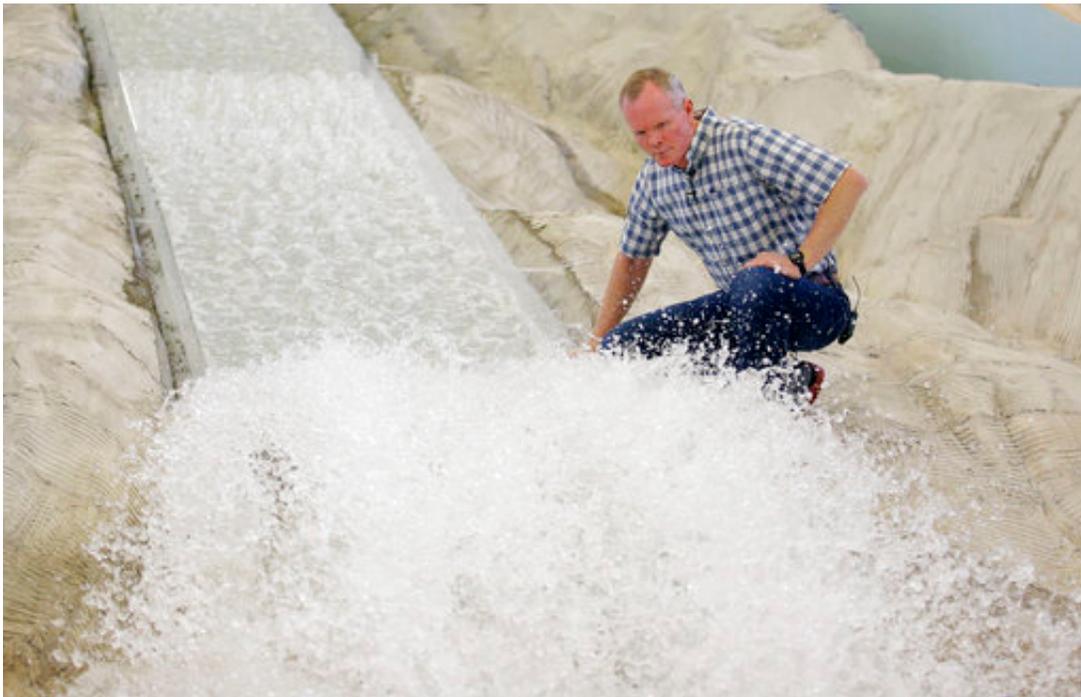
In this Friday, June 16, 2017, photo, hydraulic engineering professor Michael Johnson looks at the water flow on a replica of the Oroville Dam spillway at Utah State University's Water Research Laboratory, in Logan, Utah. California water officials are relying on key hydrology tests being performed on the replica of the spillway to pinpoint what repairs will work best at the tallest dam in the U.S for a spillway that was torn apart in February. (AP Photo/Rick Bowmer)

The sound of rushing water is deafening as Utah State University hydraulics engineering professor Michael Johnson kneels in front of a replica of an Oroville Dam spillway the size of a small house to examine one of two channels that run the width of the spillway to allow air into the water to prevent bubble formations that can damage the concrete spillway of the real dam.

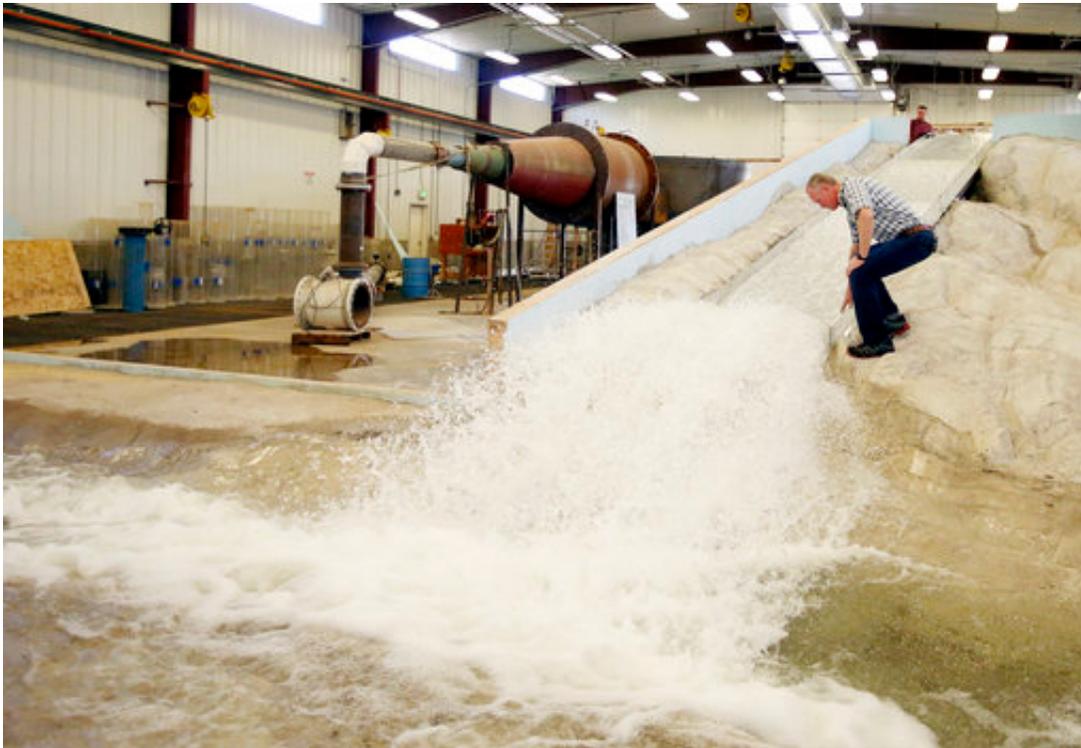
In this Friday, June 16, 2017, photo, hydraulic engineering professor Michael Johnson looks at the water flow on a replica of the Oroville Dam spillway at Utah State University's Water Research Laboratory, in Logan, Utah. California water officials are relying on key hydrology tests being performed on the replica of the spillway to pinpoint what repairs will work best at the tallest dam in the U.S for a spillway that was torn apart in February. (AP Photo/Rick Bowmer)

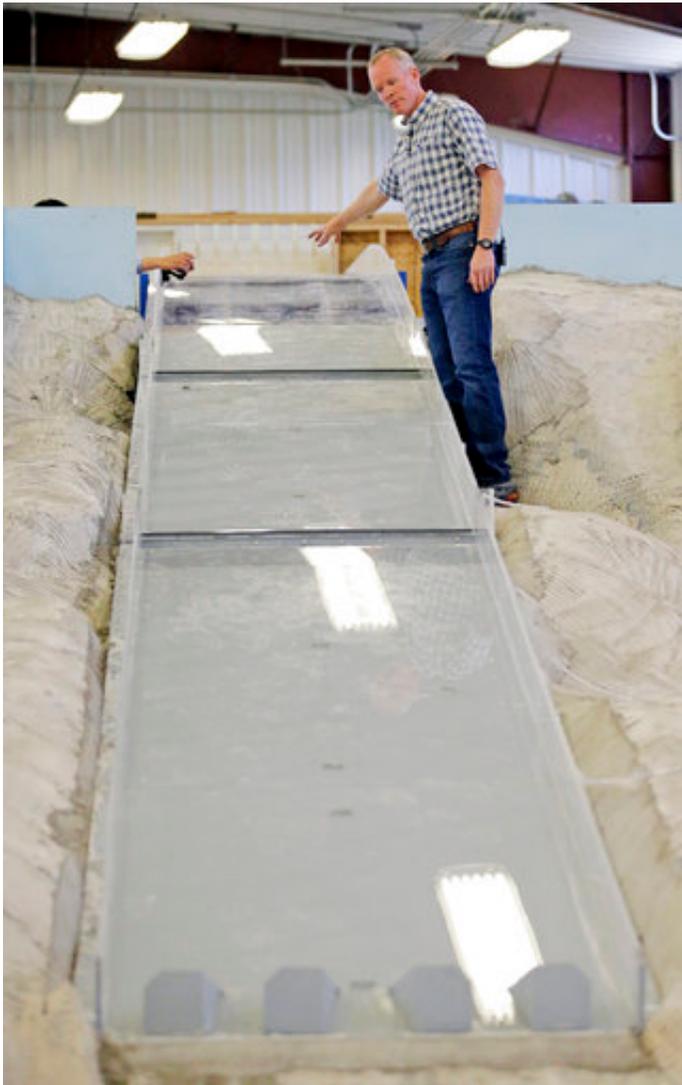
In this Friday, June 16, 2017, photo, hydraulic engineering professor Michael Johnson talks to reporters about the replica of the Oroville Dam spillway at Utah State University's Water Research Laboratory, in Logan, Utah. California water officials are relying on key hydrology tests being performed on the replica of the

spillway to pinpoint what repairs will work best at the tallest dam in the U.S for a spillway that was torn apart in February. (AP Photo/Rick Bowmer)

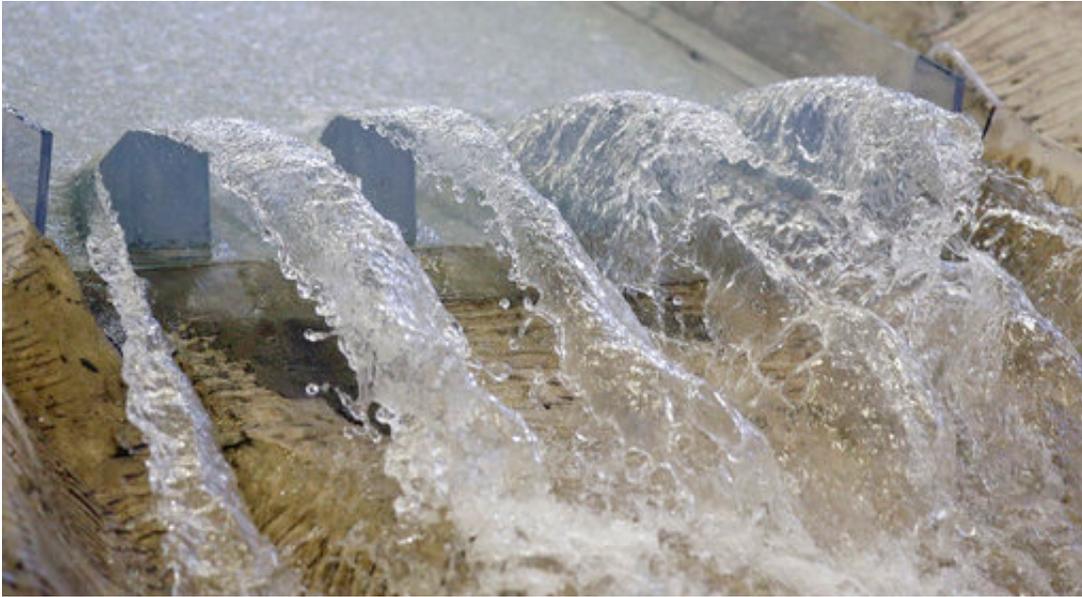
In this Friday, June 16, 2017, photo, water flows from a replica of the Oroville Dam spillway at Utah State University's Water Research Laboratory, in Logan, Utah. California water officials are relying on key hydrology tests being performed on the replica of the spillway to pinpoint what repairs will work best at the tallest dam in the U.S for a spillway that was torn apart in February. (AP Photo/Rick Bowmer)

Each simulation of the 100-foot (30-meter) long replica that took 40 days to build begins when a crew member slowly opens a large steering wheel like valve that sends water screaming down a chute modeled after the spillway and crashing into blocks that disperse it and send it in waves to a replica of the river. Johnson almost has to shout for his team to hear him above the noise of the water mimicking a flood.

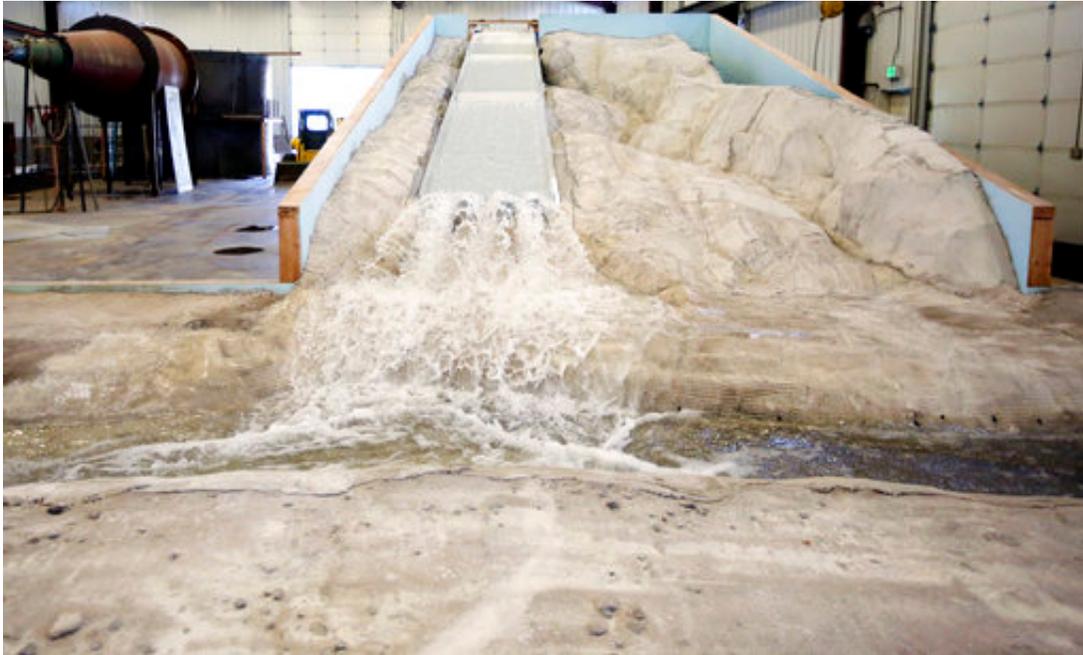
In this Friday, June 16, 2017, photo, water flows from a replica of the Oroville Dam spillway at Utah State University's Water Research Laboratory, in Logan, Utah. California water officials are relying on key hydrology tests being performed on the replica of the spillway to pinpoint what repairs will work best at the tallest dam in the U.S for a spillway that was torn apart in February. (AP Photo/Rick Bowmer)
