Engineers use replica to pinpoint California dam repairs

26 June 2017, by Brady Mccombs

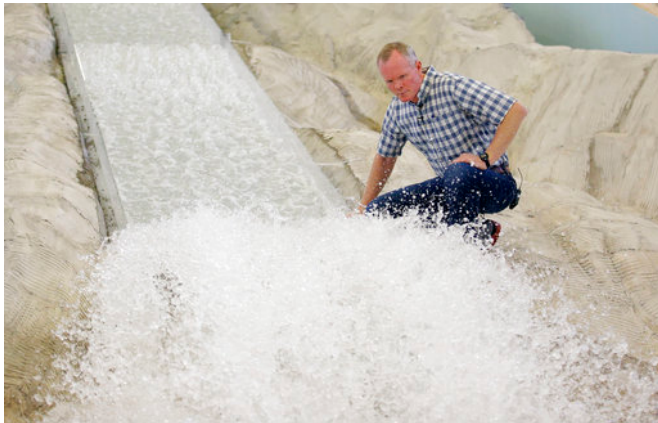
In this Friday, June 16, 2017, photo, hydraulic engineering professor Michael Johnson looks at the water flow on a replica of the Oroville Dam spillway at Utah State University's Water Research Laboratory, in Logan, Utah. California water officials are relying on key hydrology tests being performed on the replica of the spillway to pinpoint what repairs will work best at the tallest dam in the U.S for a spillway that was torn apart in February. (AP Photo/Rick Bowmer)

The sound of rushing water is deafening as Utah State University hydraulics engineering professor Michael Johnson kneels in front of a replica of an Oroville Dam spillway the size of a small house to examine one of two channels that run the width of the spillway to allow air into the water to prevent bubble formations that can damage the concrete spillway of the real dam.

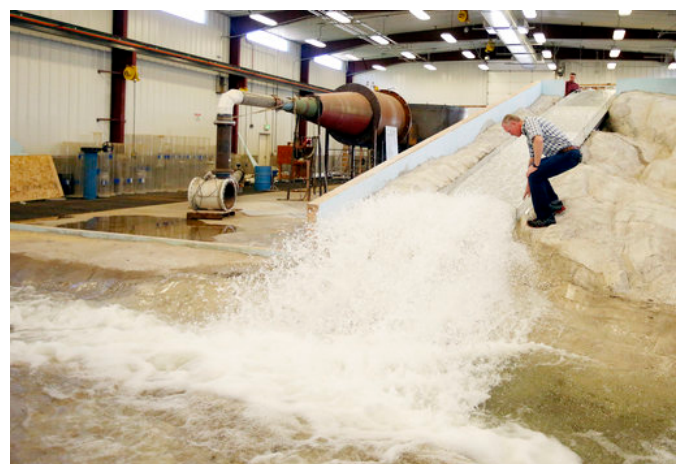
In this Friday, June 16, 2017, photo, hydraulic engineering professor Michael Johnson looks at the water flow on a replica of the Oroville Dam spillway at Utah State University's Water Research Laboratory, in

Logan, Utah. California water officials are relying on key hydrology tests being performed on the replica of the spillway to pinpoint what repairs will work best at the tallest dam in the U.S for a spillway that was torn apart in February. (AP Photo/Rick Bowmer)

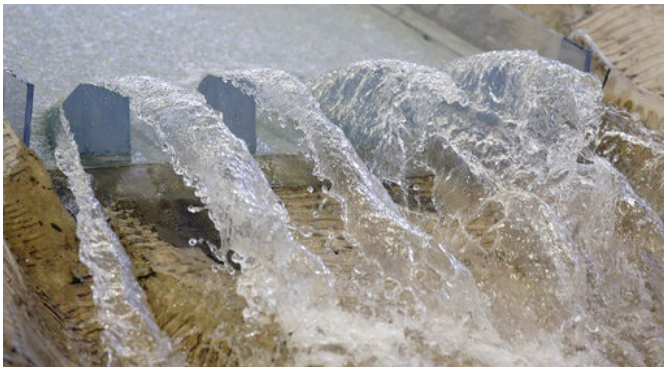
In this Friday, June 16, 2017, photo, water flows from a replica of the Oroville Dam spillway at Utah State University's Water Research Laboratory, in Logan, Utah. California water officials are relying on key hydrology tests being performed on the replica of the spillway to pinpoint what repairs will work best at the tallest dam in the U.S for a spillway that was torn apart in February. (AP Photo/Rick Bowmer)

Each simulation of the 100-foot (30-meter) long replica that took 40 days to build begins when a crew member slowly opens a large steering wheel like valve that sends water screaming down a chute

modeled after the spillway and crashing into blocks that disperse it and send it in waves to a replica of the river. Johnson almost has to shout for his team to hear him above the noise of the water mimicking a flood.

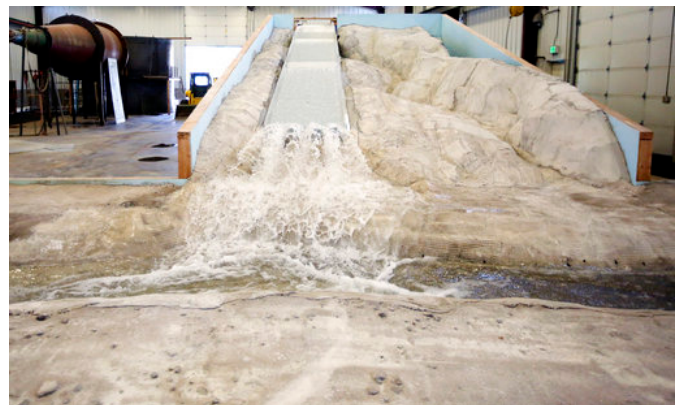
In this Friday, June 16, 2017, photo, water flows from a replica of the Oroville Dam spillway at Utah State University's Water Research Laboratory, in Logan, Utah. California water officials are relying on key hydrology tests being performed on the replica of the spillway to pinpoint what repairs will work best at the tallest dam in the U.S for a spillway that was torn apart in February. (AP Photo/Rick Bowmer)
