# Permafrost in continuous motion

January 25 2018, by Peter Rüegg

ETH researchers have identified a rock glacier in canton Valais that is degrading and moving very quickly. Fortunately, it does not present an immediate threat to people and infrastructure.

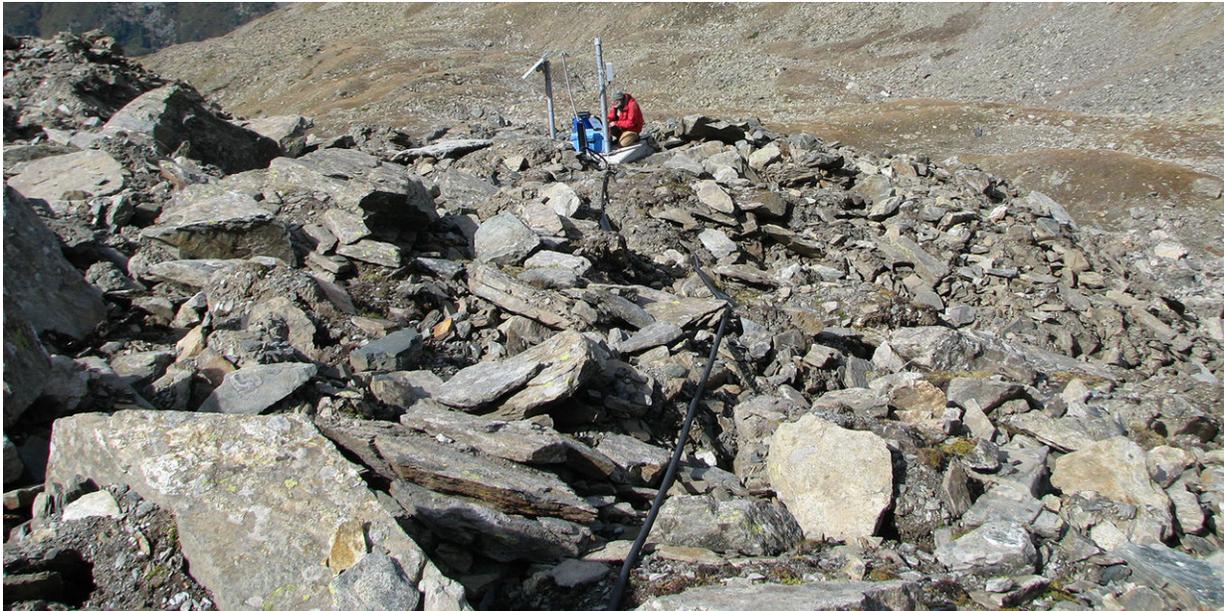
Nothing stands still for long here: measurement station on the rock glacier at the foot of the Furggwanghorn mountain. Credit: Thomas Buchli / ETH Zurich

When writing his dissertation, the geotechnical engineer Buchli collaborated with geophysicists, hydrologists and geologists, using an impressive arsenal of measuring and monitoring equipment that was positioned on and near the Furggwanghorn rock glacier.

Among other things, the researchers used radar and laser measuring devices to characterise the surface. With the help of GPS, they also determined the surface creep velocity of the rock glacier. To investigate

the structure of the ground, the temperature and water content, as well as the internal creep rates, the engineers bored several holes up to 30 metres deep into the permafrost. They inserted thermistors to measure the temperature and also novel inclinometers in these boreholes. Some of the measurements were unique: in one borehole, for example, Buchli was able to detect for the first time continuous creep movements by the rock glacier of up to three metres. The researchers gained additional information on the stratification and structure of the rock glacier with geophysical investigations.

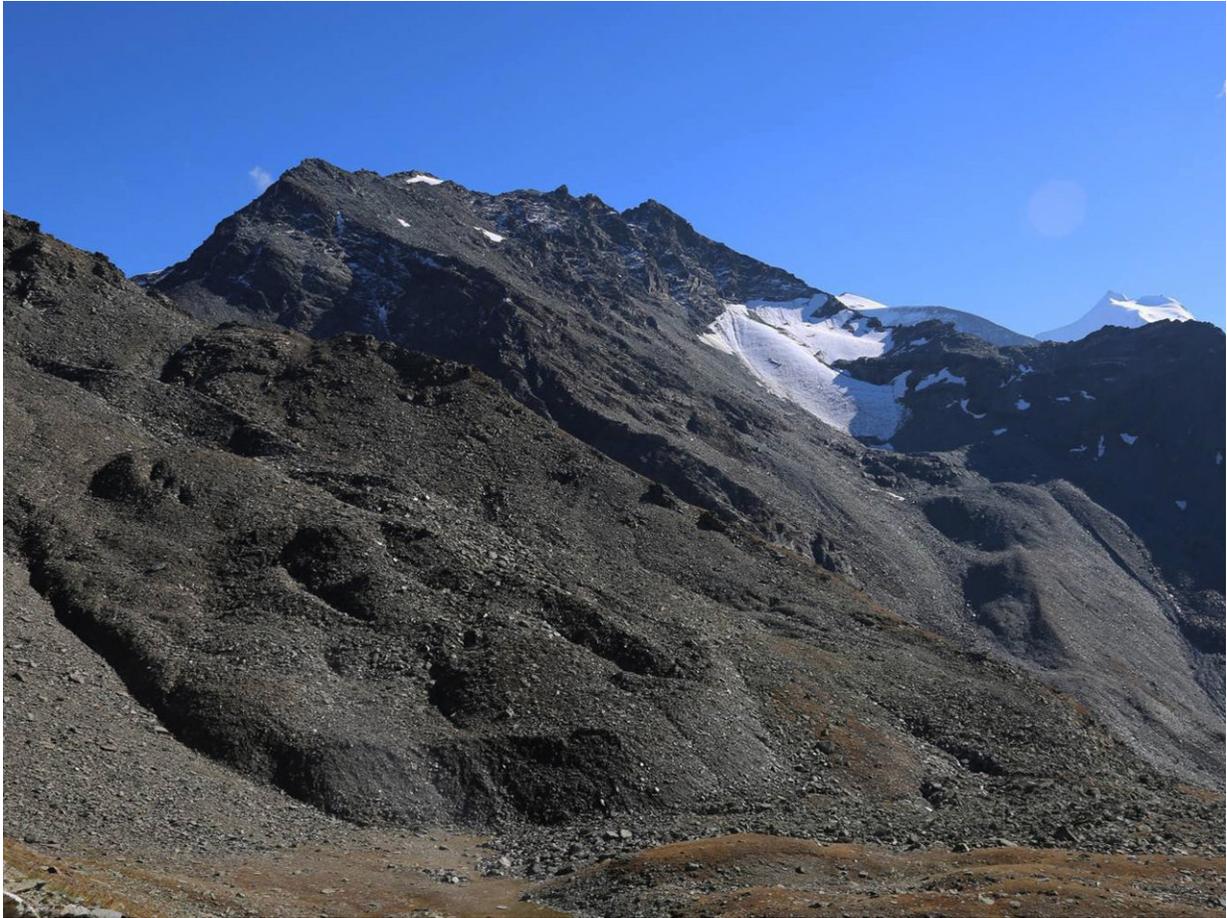
The surface of the rock glacier pictured on the left in the canton of Valais is changing rapidly as it moves downhill at a steadily increasing pace. Credit: ETH Zurich

It was striking how quickly and powerfully the surface of the rock glacier moved and changed during the investigation period. Scientists already knew that the Furggwanhorn rock glacier is warming and degrading faster than the majority of other rock glaciers. "Even so, I was surprised by the speed," says Buchli. "Tilting, twisting, subsiding –everything on the rock glacier was somehow in constant motion."

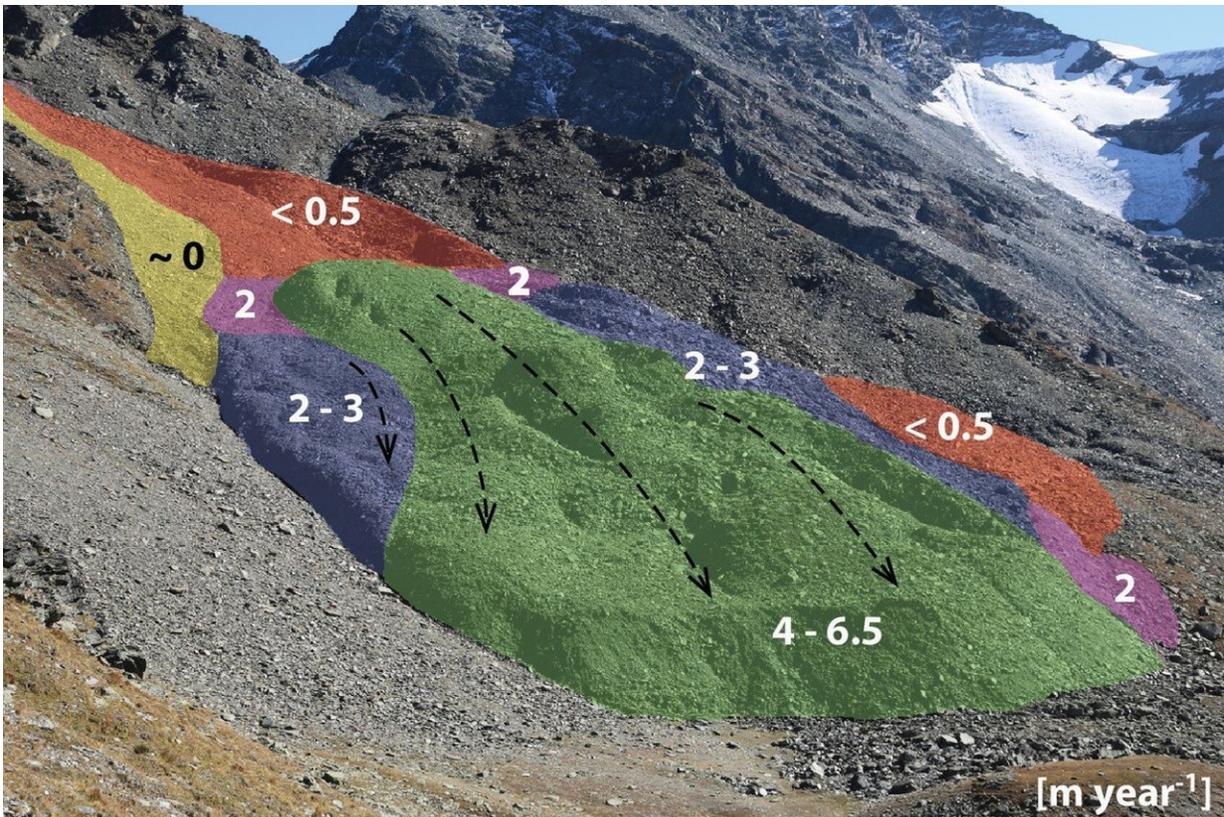
The surface of the rock glacier showing zones with different creep velocities.  
Credit: Thomas Buchli / ETH Zurich

However, the rock glacier did not move as one mass, but in sections. It moved downhill over several metres per year in one part of the frontal area, while the movement in its accumulation zone was only a few decimetres and it was entirely static in another part of the front section.
