Image: SMART-1's crash site

4 September 2018

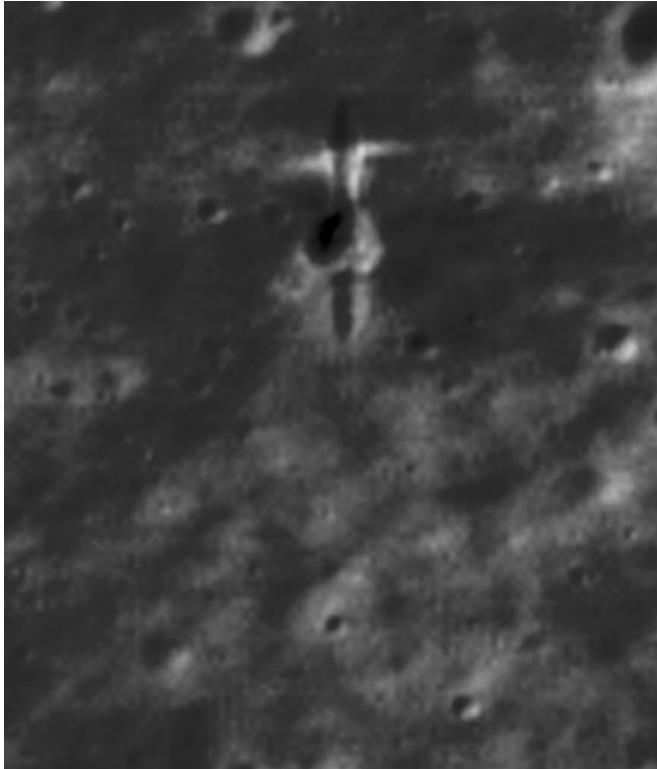
This greyscale, mottled image shows a patch of the moon's surface, and features an intriguing shape towards the top of the frame. This was actually made by a spacecraft – it marks the final resting place of ESA's SMART-1 (Small Missions for Advanced Research in Technology-1).

Last year, high-resolution images from NASA's Lunar Reconnaissance Orbiter (LRO) revealed the whereabouts of SMART-1 – as shown here. The spacecraft carved out a four-metre-wide and 20-metre-long gouge as it impacted and bounced at 34.262° south, 46.193° west. It cut across a small crater and sent [lunar soil](#) flying outwards from its skidding, ricocheting path, creating the brighter patches of material seen either side of the crater, with debris from spacecraft and oblique dust ejecta coming to a halt several to tens of kilometres in the forward stream direction.

The field of view in the image is 50 metres wide (north is up), with solar illumination coming from the west. SMART-1 touched down from north to south.
