South Africa needs to refresh how it manages by-products from mining

December 5 2018, by Charles Macrobert

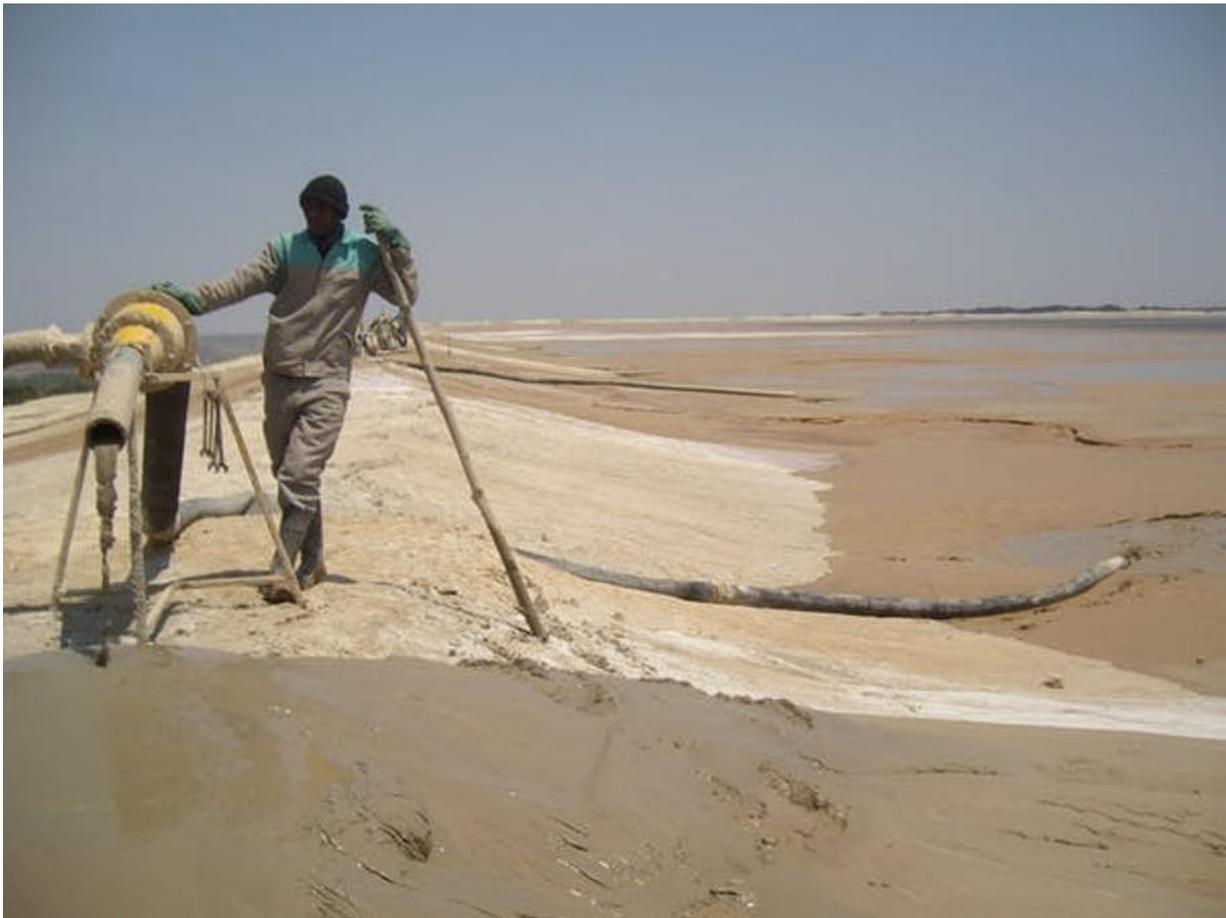
A gold tailings dam under construction in South Africa. Author supplied

To extract minerals from host rocks, mines grind down rock into fine

sand. Once the mineral is extracted, most of this fine sand remains as a by-product called tailings. Every mining operation produces a unique tailings stream and local conditions dictate storage options.

In countries like South Africa which has a big and robust mining sector, [tailings](#) need to be managed with extra care. Typically they're conveyed as a slurry and placed into dams that are incrementally built over a mine's life. This watery tailings slurry takes a long time to dry out and [gain strength](#), resulting in unique challenges. If they aren't managed correctly, the results can be disastrous – and even fatal.

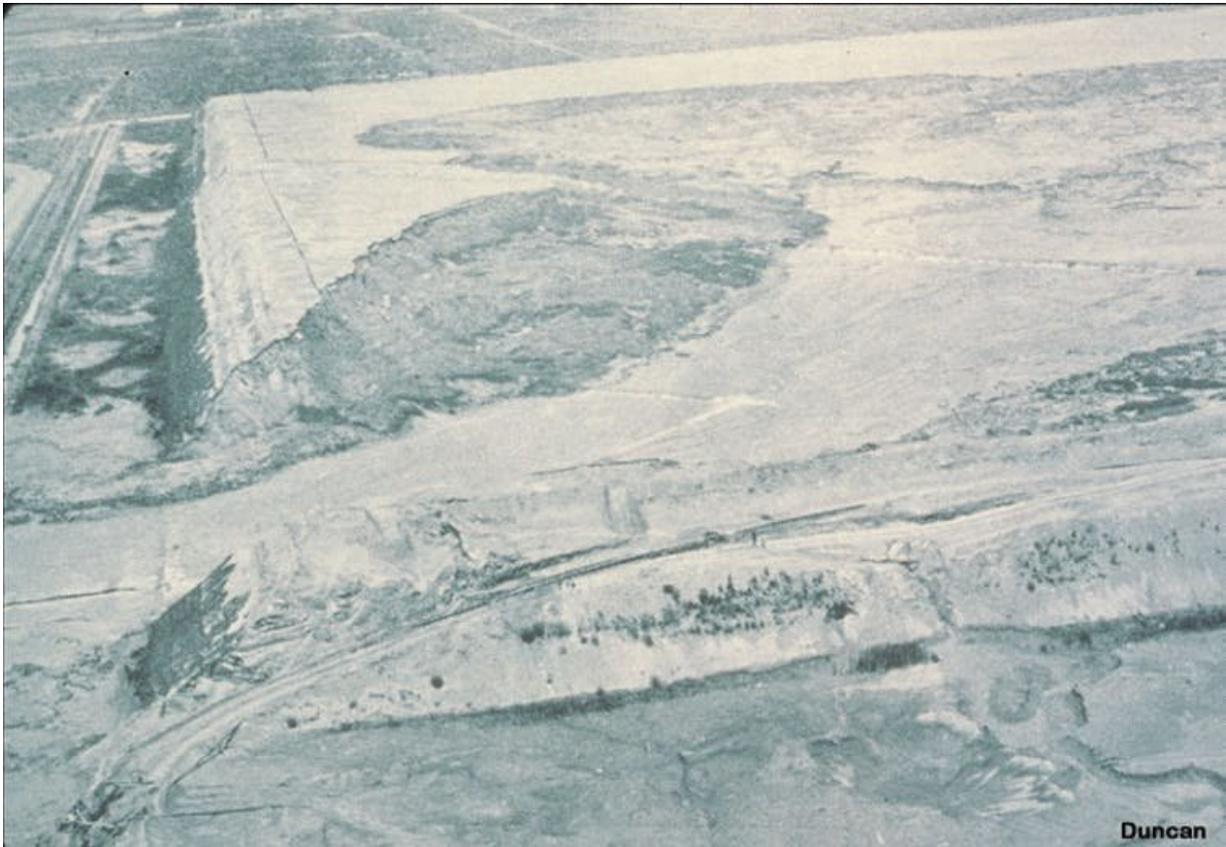
Bottom left corner shows the breach at Bafokeng Mine with the scar of released material extending into the middle of the dam. Credit: M Duncan

Forty four years ago a platinum tailings dam operated by the Bafokeng Mine [failed tragically](#). Tailings from the dam flowed 45 km flooding a mine shaft, trapping and killing 12 miners.

Various theories were put forward for [the failure](#). In the end the likely cause was identified as being concentrated seepage through the dam wall. Poor management of water on the dam surface and heavy rain prior to the [failure](#) were equally considered causes of the failure.
