Spacewalking astronauts check site of capsule leak

11 December 2018, by Marcia Dunn

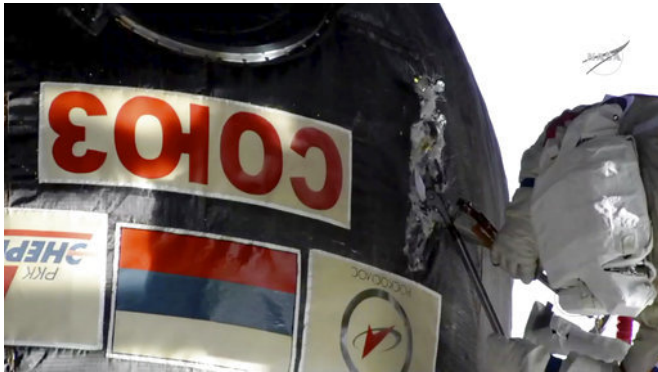
In this image from video made available by NASA, Russian cosmonaut Oleg Kononenko cuts into the insulation on the Soyuz spacecraft attached to the International Space Station on Tuesday, Dec. 11, 2018. Kononenko and Sergei Prokopyev are investigating a mysterious leak which appeared on Aug. 30. (NASA via AP)

To expose the external hull, Kononenko needed to cut away a 10-inch (25-centimeter) swatch of thermal insulation and debris shield.

Bits of shredded silver insulation floated away like confetti, as the two slashed at it with a knife and long cutters. Mission Control repeatedly urged the spacewalkers to take a few minutes' rest, in their bid to collect samples of the black epoxy sealant protruding from the hole, just one-tenth of an inch (2 millimeters) across.

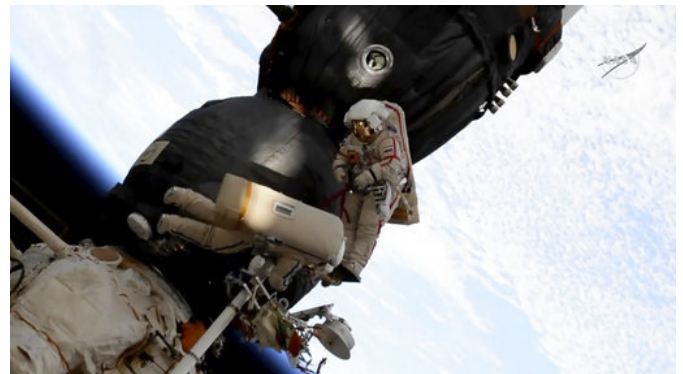
In this image from video made available by NASA, Russian cosmonaut Oleg Kononenko, right, and Sergei Prokopyev perform a spacewalk outside the Soyuz spacecraft attached to the International Space Station on Tuesday, Dec. 11, 2018. They are investigating a section where a mysterious leak appeared on Aug. 30. (NASA via AP)

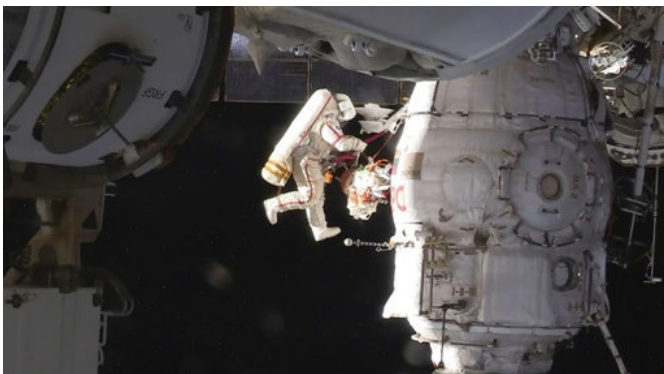
In this image from video made available by NASA, Russian cosmonaut Oleg Kononenko performs a spacewalk outside the International Space Station on Tuesday, Dec. 11, 2018. Kononenko and Sergei Prokopyev are inspecting a section where a mysterious leak appeared on Aug. 30. (NASA via AP)
