# NSF plans to decommission Arecibo Observatory's 305m telescope due to safety concerns

November 19 2020

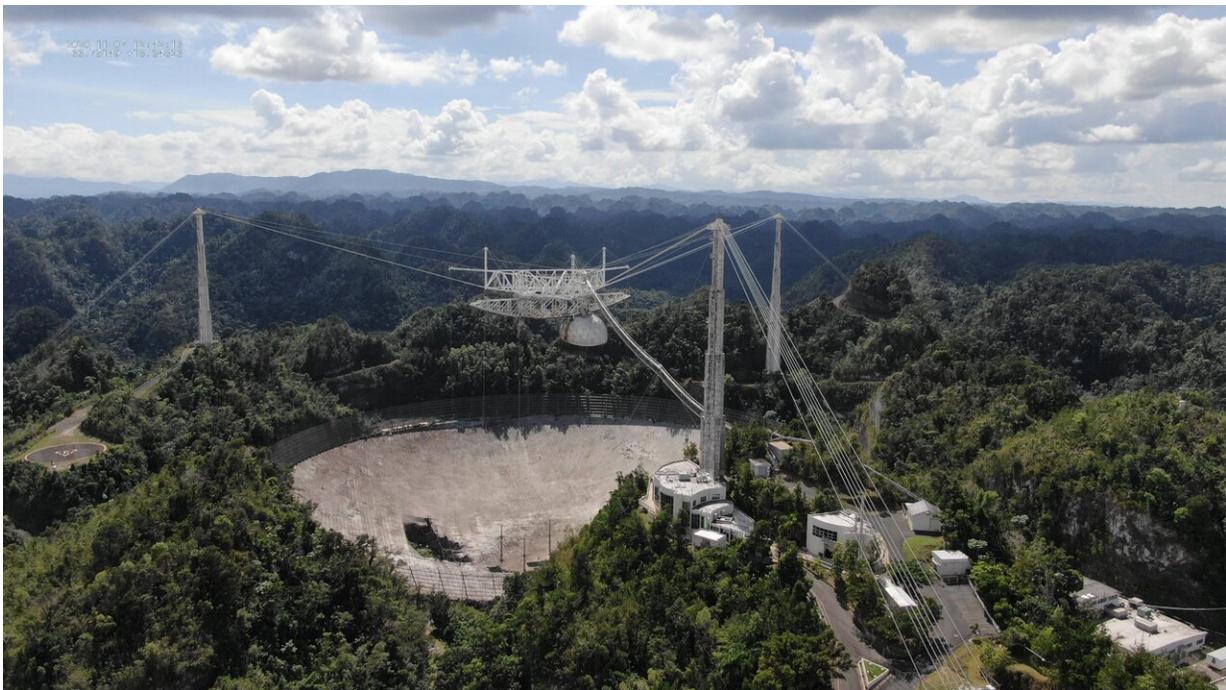
Arecibo Observatory's 305-meter telescope in November of 2020. Credit: University of Central Florida
