NASA spacecraft leaves its mark after grabbing asteroid Bennu samples

April 16 2021, by Marcia Dunn

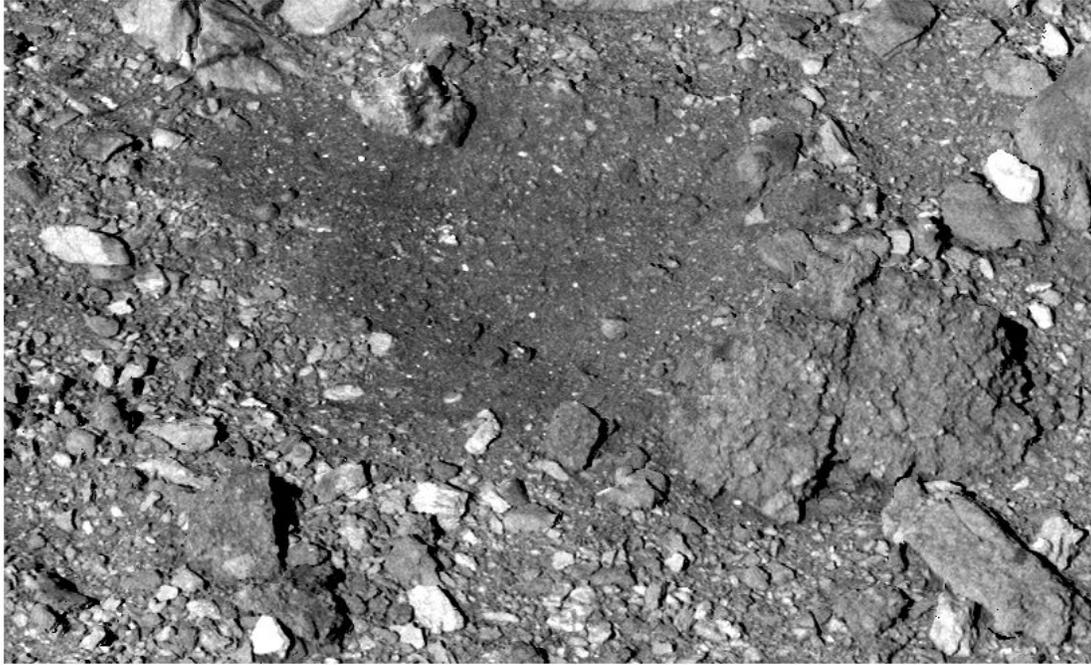
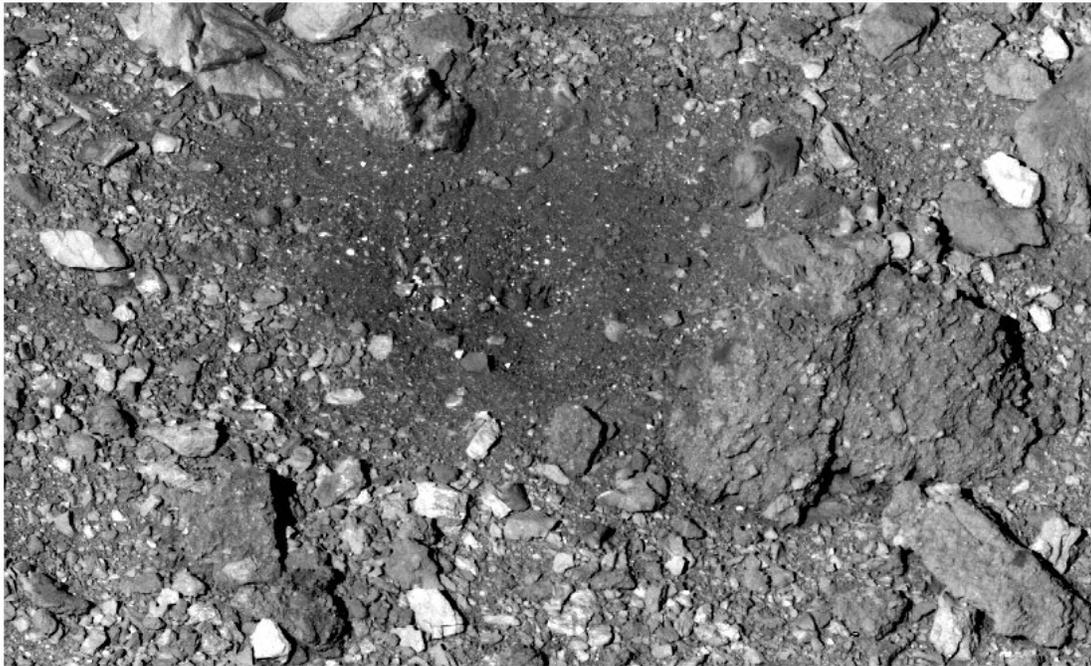
This combination of 2019 and 2021 images made available by NASA shows how the local surface of Bennu changed after the OSIRIS-REx spacecraft took a

sample of the asteroid on Oct. 20, 2020. The earlier image, top, was taken on March 7, 2019, and the bottom was taken on April 7, 2021, as part of final observations to document the surface after sample acquisition. The Nightingale site is located in the relatively clear patch just above the crater's center – visible in the center of the earlier image. The large, dark boulder located at the center right measures 43 feet (13 meters) on its longest axis.

A depression is visible where Osiris-Rex penetrated the asteroid's surface. Boulders were hurled by the pressurized nitrogen gas that was fired at the ground to churn up material for vacuuming, and by the spacecraft's getaway thruster. One 1-ton boulder was flung an estimated 40 feet (12 meters).

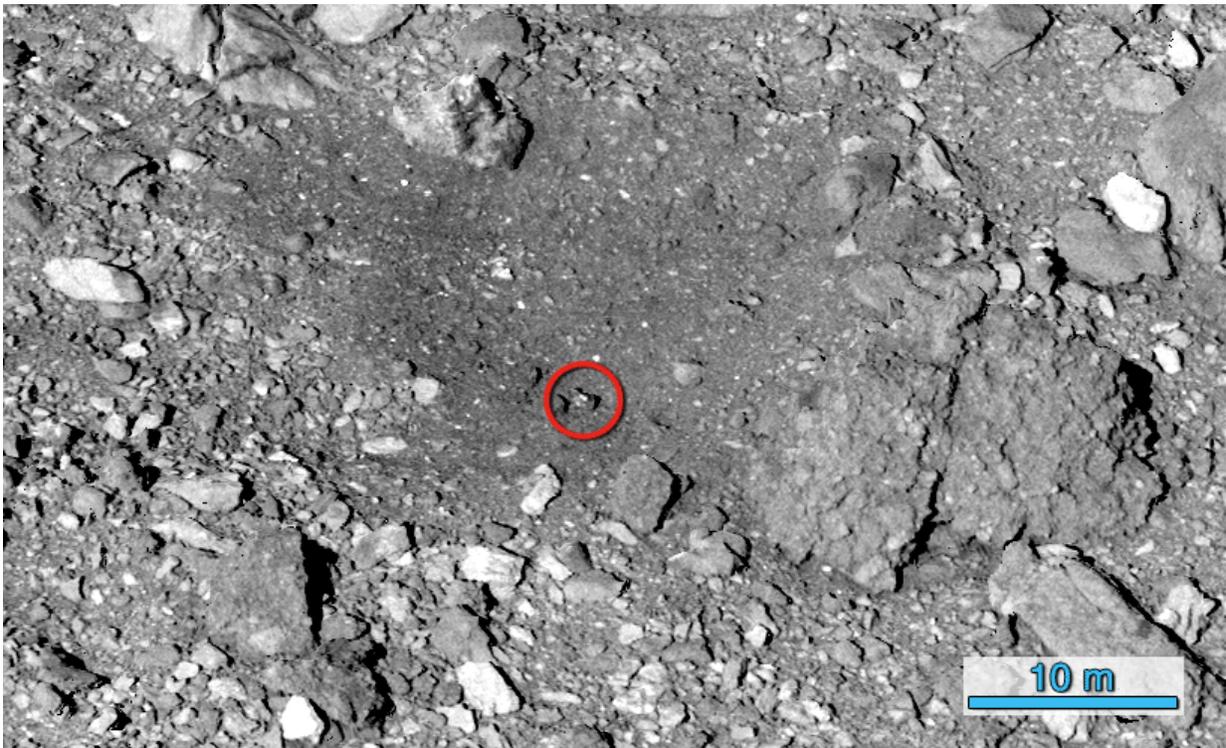
Bennu's surface was disturbed in three different ways: by the force of the spacecraft touching down; by the sampling mechanism, which collected material by blowing gas into its collection filter; and by four of the spacecraft's back-away thrusters, which moved the spacecraft away from the sample site (marked with a red "X" in the second of these two images) and agitated dust and boulders on the surface. The image above shows the TAG site and highlights (red circle) a large boulder thrown about 40 feet (about 12 meters). Credits: NASA/Goddard/University of Arizona
